# West Central Area School District

Facility Assessment &  
Educational Adequacy Study

June 24th, 2024 - Final Report

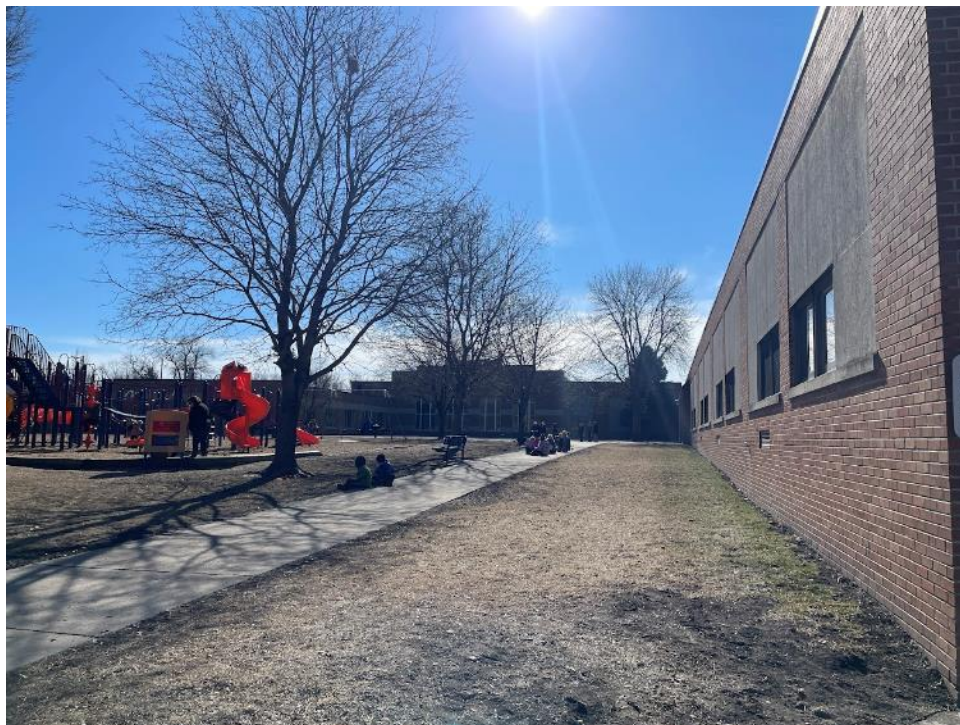
*\*North playground with poor site conditions, lack of turf, and mudding conditions. Not ADA compliant.*

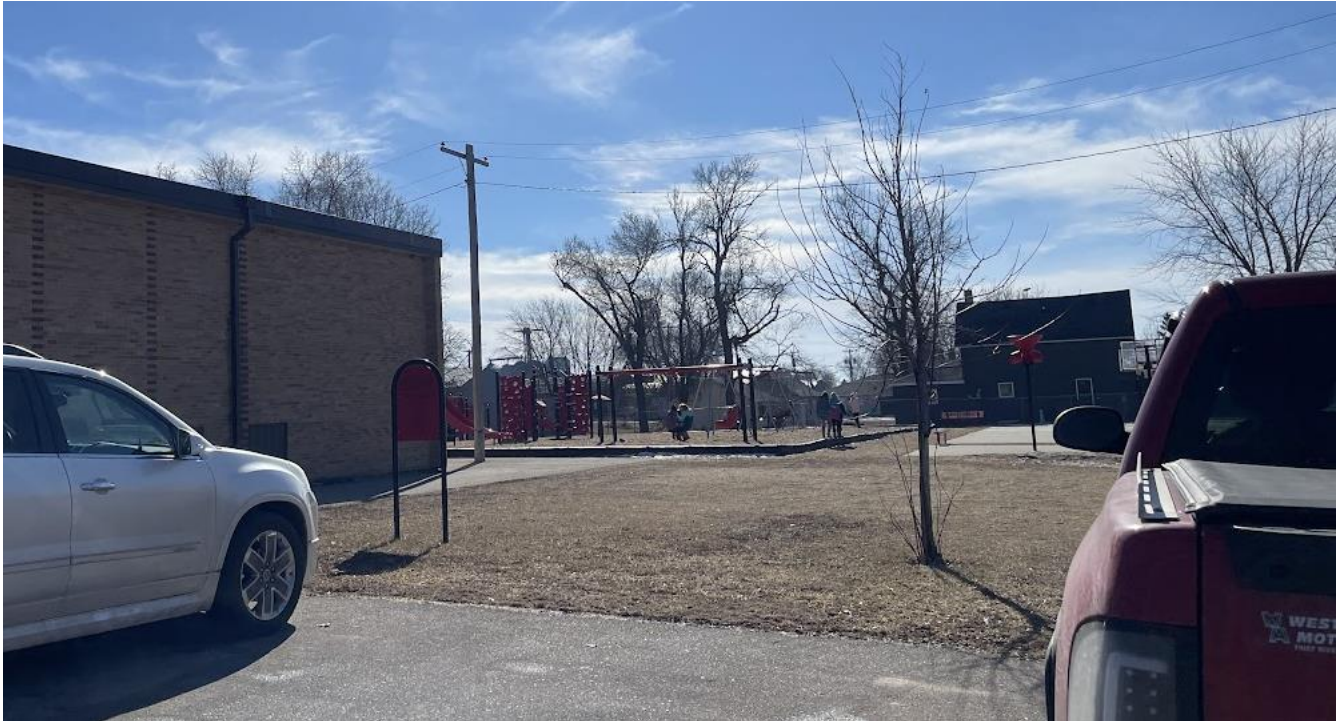
*\*South playground with poor site conditions, lack of turf, and mudding conditions. Not ADA compliant. In close proximity to heavily utilized parking lot.*

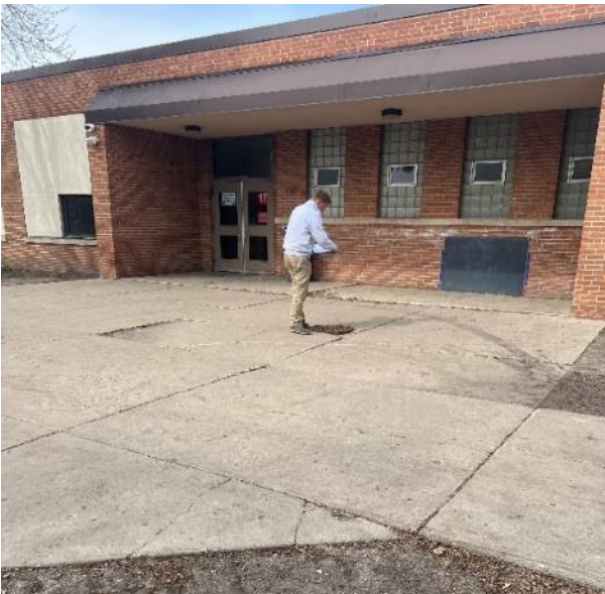
The existing sidewalks and stairways do not meet American with Disabilities Act (ADA) standards. Trip hazards, inconsistent stair riser heights, and inadequate handrails pose safety risks to students, staff, and visitors. The sidewalks show signs of significant wear, including cracks, and settlements.

1. Areas where concrete has settled or raised more than  $\frac{1}{4}$  inch creates trip hazards, violating ADA standards.
2. The concrete stairways lack continuous handrails on both sides, which is required by ADA guidelines.
3. The riser heights vary within a set of stairs, leading to non-uniform steps.

Building entrance from courtyard.

It is recommended that all existing sidewalks and stairways be replaced with new, ADA-compliant structures. A trench drain with a solid cast iron cover should be installed across the sidewalk to replace the small diameter, plastic pipe that runs under the existing sidewalk. A small portion of concrete curb and gutter will need to be replaced on 1<sup>st</sup> Street SE to accommodate the new trench drain.

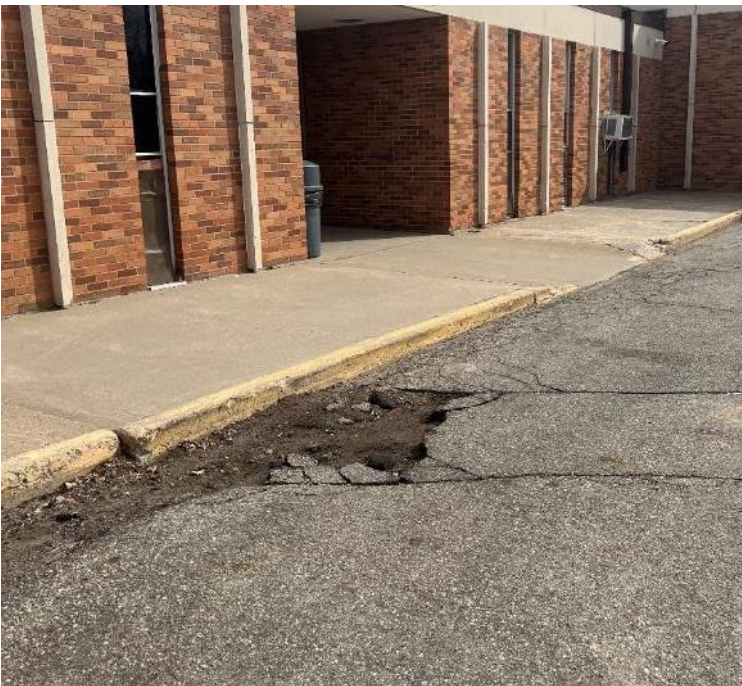
The existing curb surrounding the bituminous parking lot on the facility's south side is in poor condition. Additionally, there is no gutter on the existing curb to convey the flow of water. Parts of the curb are painted, but the paint has faded significantly.

Curb in front of the south facility entrance.

It is recommended that all the existing curbs be replaced with a new curb and gutter system. This will convey water away from the buildings and towards the city street to the south. Handicap parking and pedestrian entry points will be painted for improved visibility.

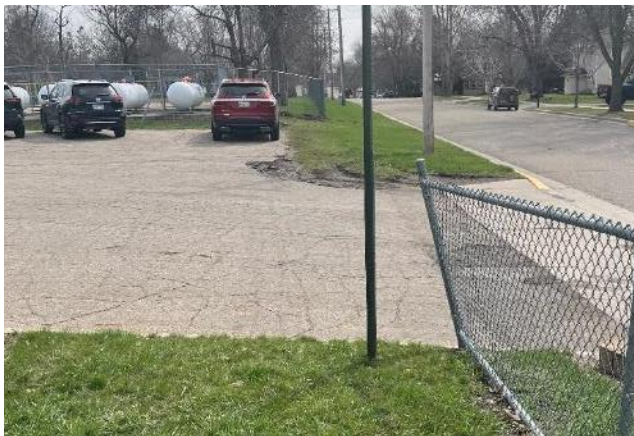
The existing bituminous pavement in the south parking lot is in poor condition. Alligator cracking is prevalent across the entire parking lot. The pavement markings are barely visible.

South parking lot entrance.

It is recommended that the entire parking lot be replaced with new bituminous pavement and pavement markings.

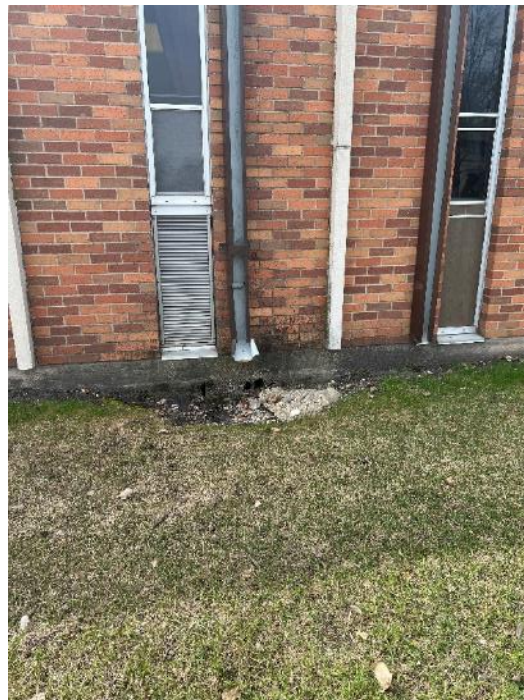
Erosion and undermining beneath downspout.

It is recommended that concrete be poured to plug the visible holes. It is also recommended that a concrete splash pad be poured directly under the downspout sloping away from the building to prevent erosion in the future.

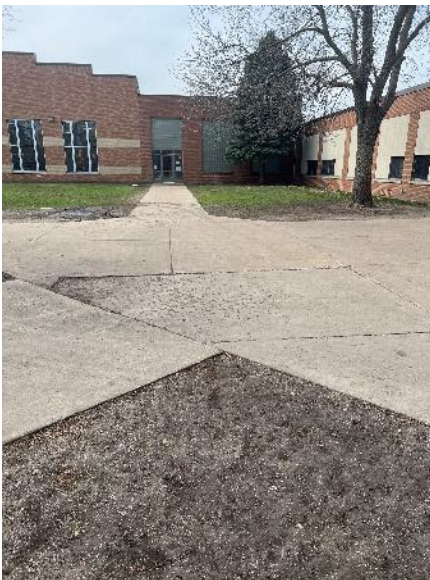
The current condition of the green space situated towards the center of the facility indicates inadequate drainage. Simply regarding and sloping the area may not sufficiently address the issue.

Drainage issues in green space.

Install a storm sewer system equipped with multiple inlets strategically placed throughout the green space in the center of the facility. The storm sewer network should discharge onto the northern street, effectively diverting water away from the buildings. To facilitate this, it's necessary to install a trench drain featuring a solid cast iron cover. Additionally, a segment of curb and gutter along the street will require removal and replacement.

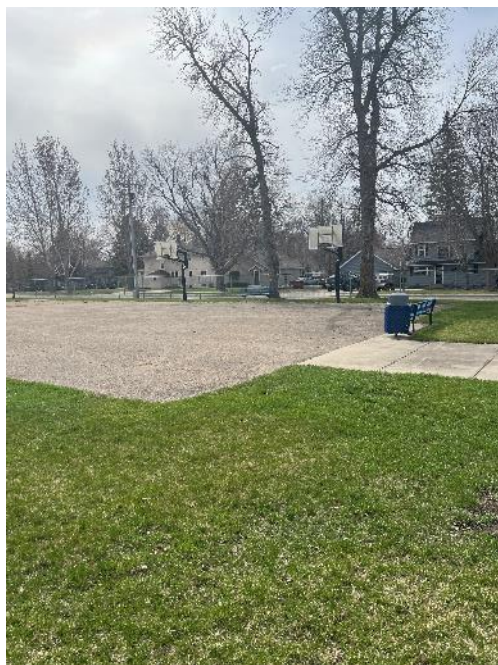
Basketball court bituminous pavement.

It is recommended that the basketball court be reclaimed, reshaped, and paved in the future.

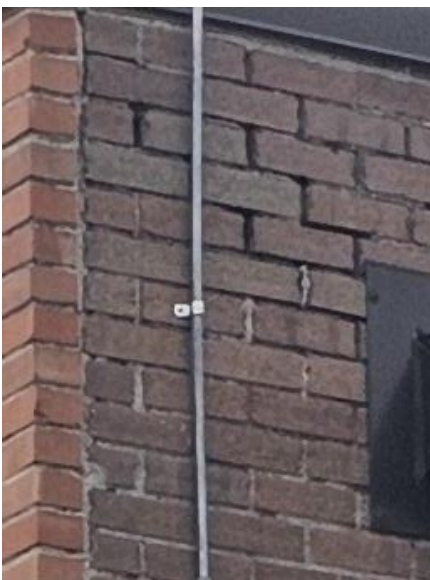
Joint / Tuckpoint repair

Prior to any mortar replacement work commencing, the building will need to be washed to remove the dirt and debris that has accumulated on the building over time. It is critical for the mortar to be in similar color, texture and compressive strength to match the existing mortar.

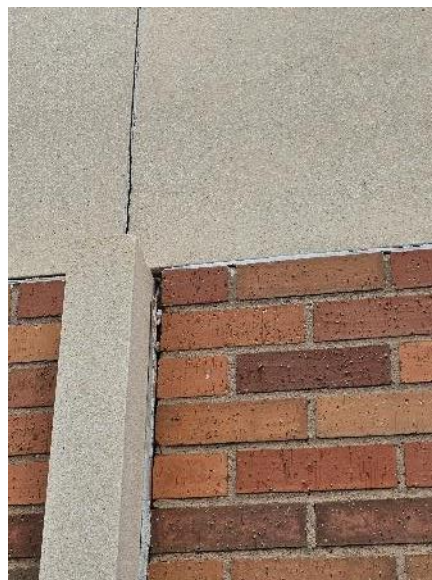
Deteriorated joints

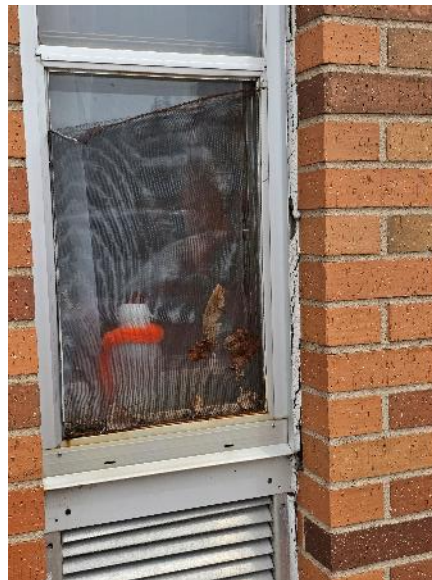
Deteriorated window sealant

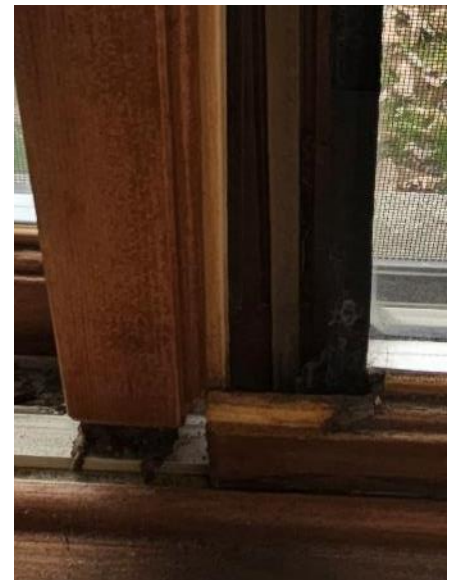
Broken window

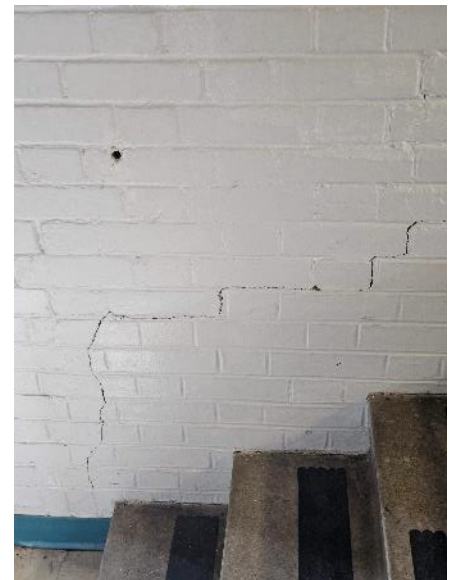
Cracking near Door 4 - likely due to settlement

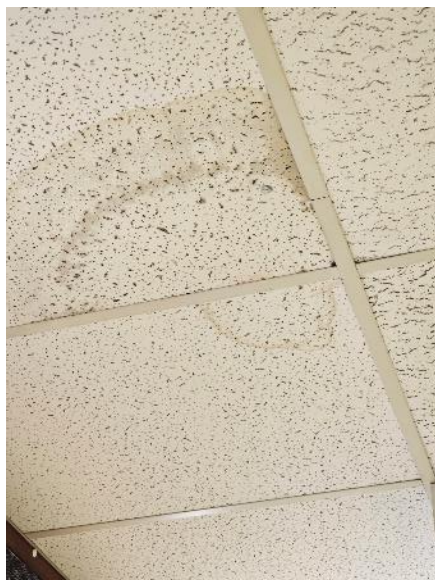
Stained ceiling tile

Replace ceiling tiles as required.

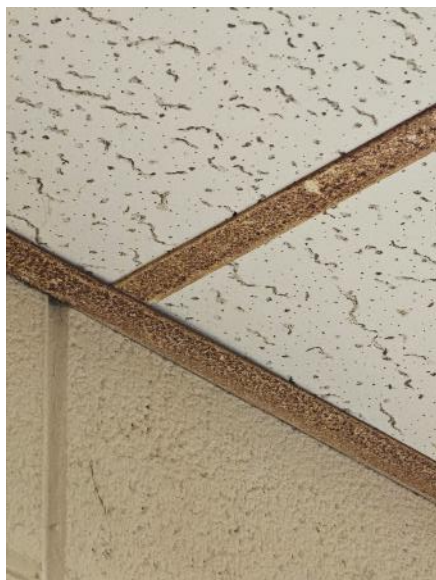
Rusted ceiling grid

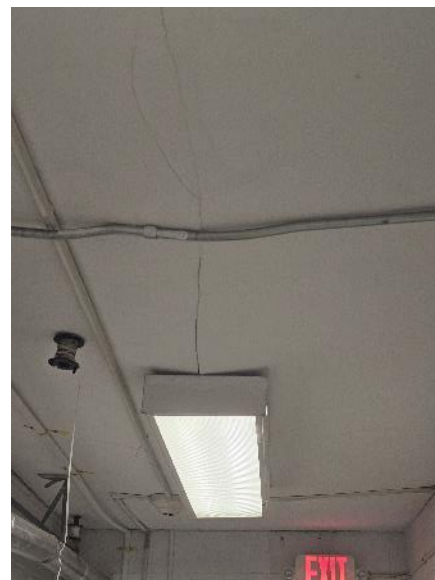
Cracked and sagging ceiling near Kitchen

The Kitchen hallway ceiling should be specifically investigated and assessed to determine the cause and nature of the damage.

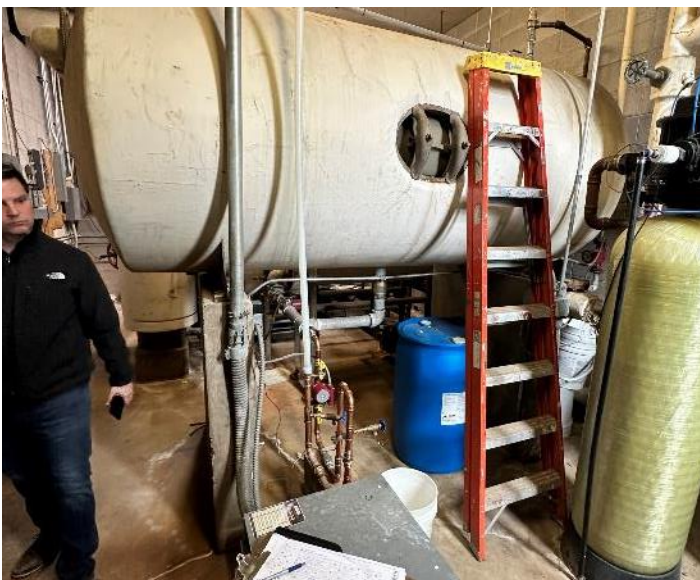
Shell and Tube Heat Exchanger

Budget for removal of Shell and Tube Exchanger and circulating pumps with the upgrade to hot water boilers. Replace current water/ auto antifreeze and replace with proper glycol / water percentages.

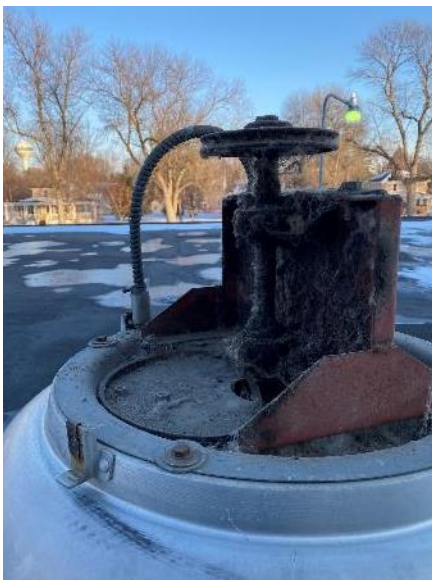
PRV – Missing motor.

For a well-designed HVAC system to operate correctly, Outdoor Air and Exhaust Air need to be working. The PRVs shall be replaced with new as they are not worth repairing. Exhaust fans shall be designed with direct drive motors to reduce maintenance time and costs.

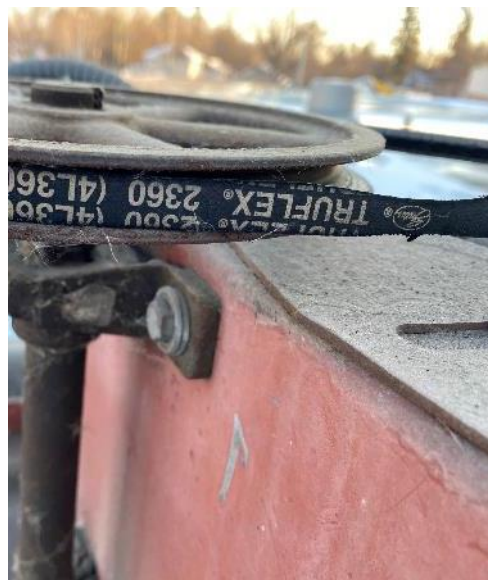
PRV – Maintenance Required

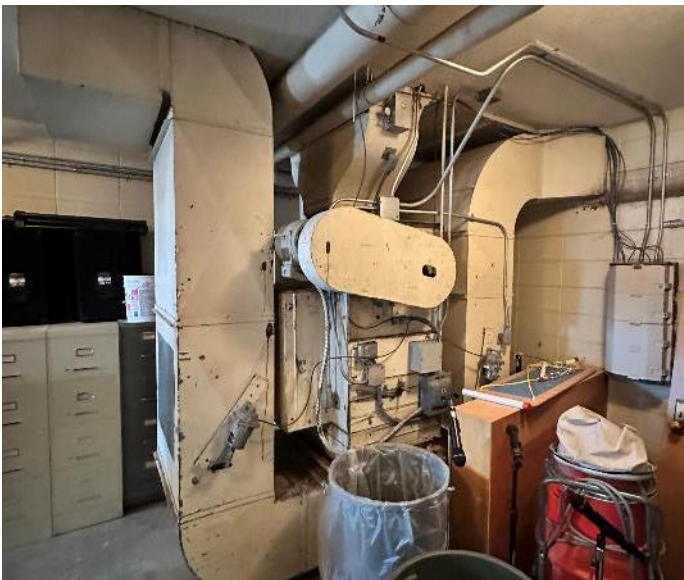
Indoor AHU – Heating Only

The AHUs are operational for now but should be replaced with upgraded systems which employ more efficient technologies such as variable speed fans, digital controls, and more accurate outdoor air measures. The replacement units can be mounted in place or on the roof to gain more storage if needed. The new units shall be sized with cooling / dehumidification. A unit shall be added for the west wing and incorporate ductwork to each classroom with a VAV system with hot water reheats.

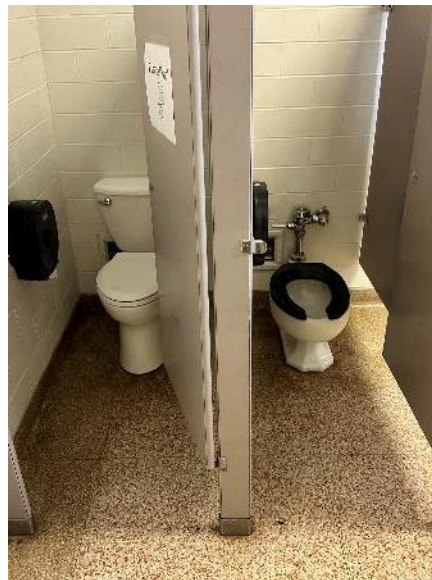
Replacement water closets do not match

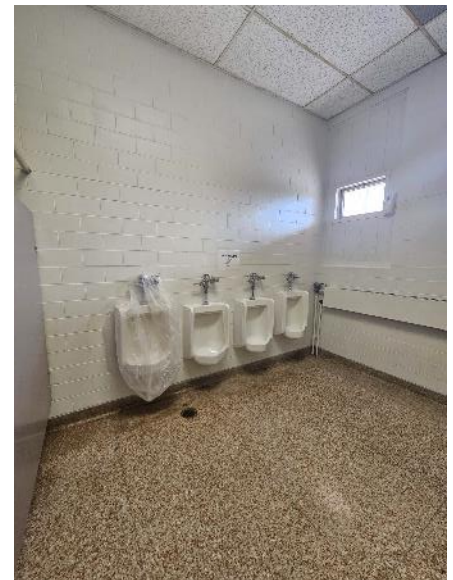
Inoperable fixtures

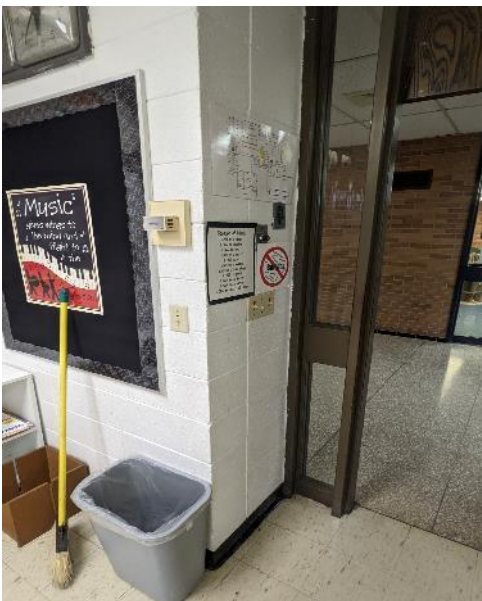
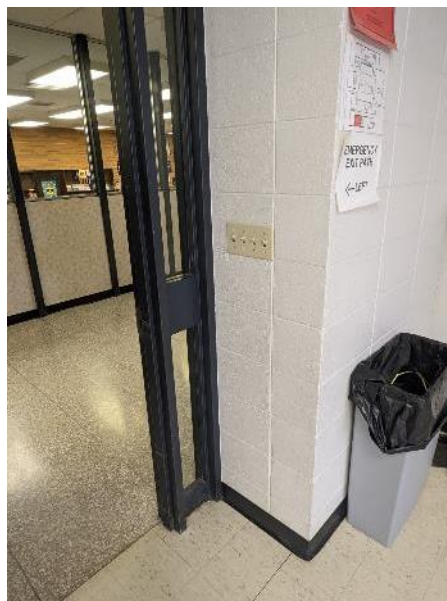
Examples of standard on/off switching in most locations

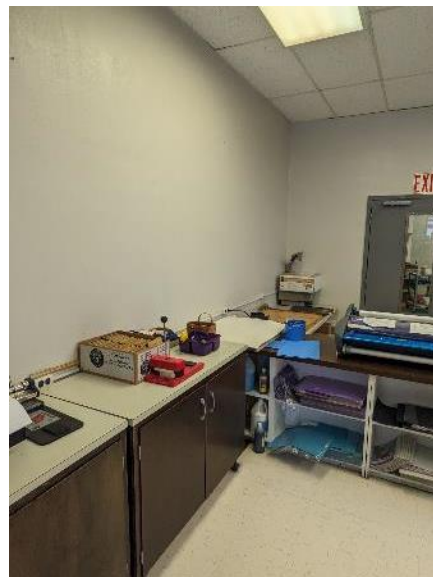
Non-Illuminated Exit Signs in Teacher's Lounge 19W

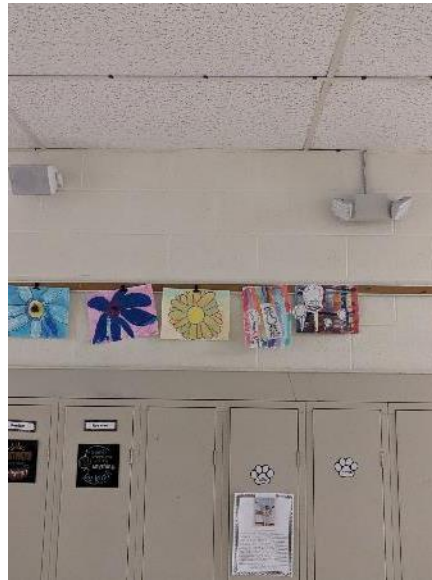
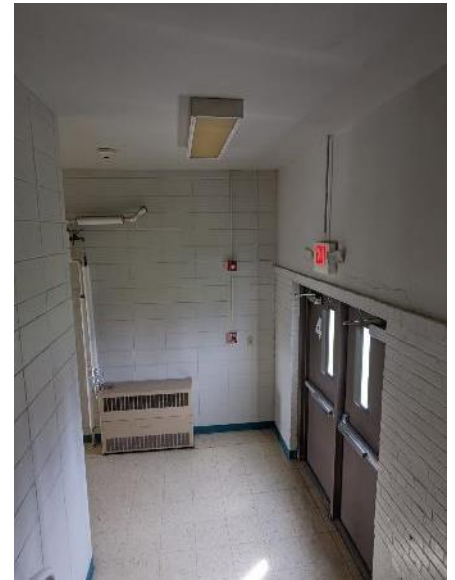
Examples of exit signs and emergency lights that require annual testing.

It is recommended to conduct annual testing of all powered exit sign and emergency lights, and repair and/or replacement of exit signs and emergency lights as needed.

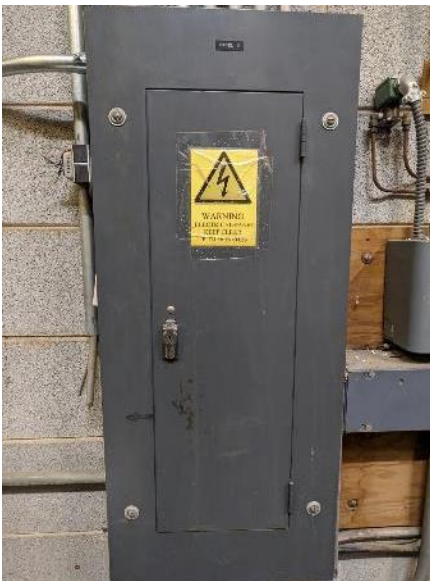
See below for photos of ITE branded panels in need of replacement within the next 10 years.

Panel E in Boiler Room A133

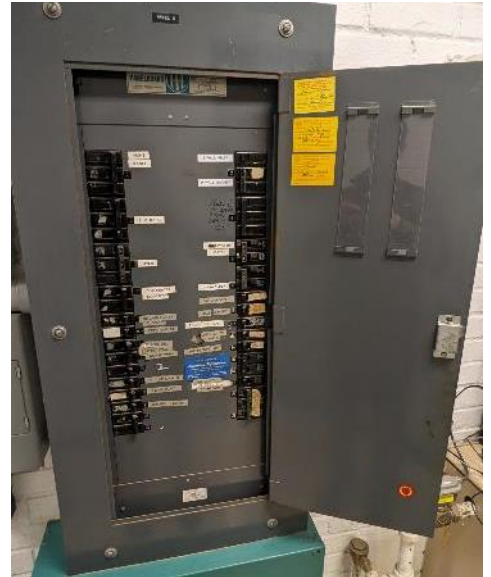
Panel K in Receiving B137

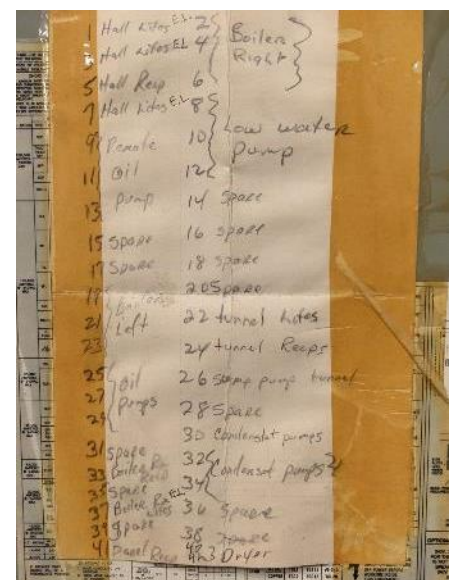
Examples of panels needing updated labels and circuit directories

It is recommended to hire an electrician to verify all the electrical loads in the building and provide up-to-date labeling and circuit directories for all the electrical distribution equipment.

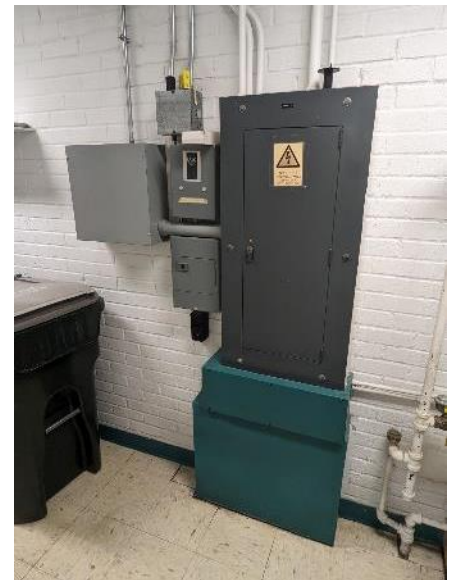
Examples of electrical equipment needing annual preventative maintenance

**ELO 5b** - Have electrical panels and distribution equipment cleaned. Dust build-up in panels can lead to nuisance tripping of circuit breakers, or even arcing and catastrophic failure in extreme cases.

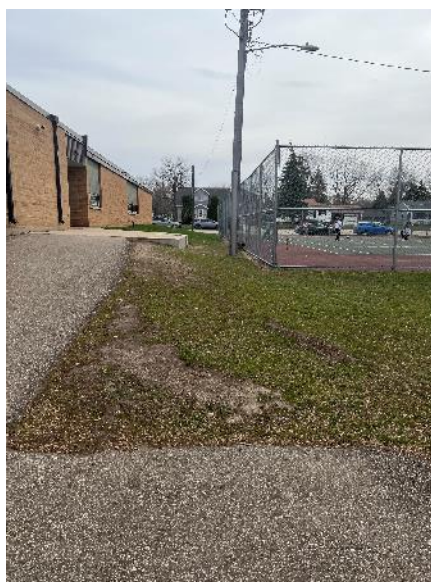
Tennis court.

It is recommended that in the future the tennis court be resurfaced. This would include removal and replacement of the surrounding fence and net.

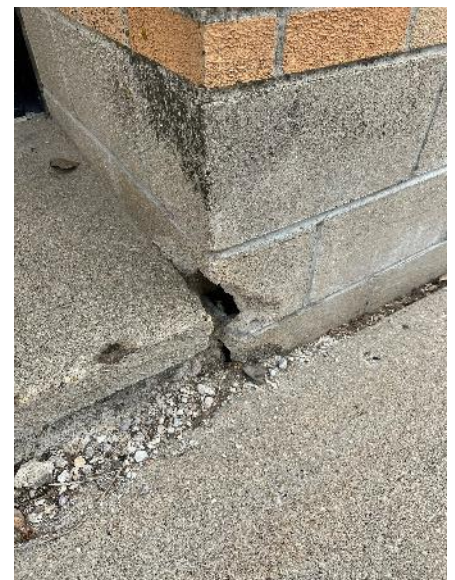
Damaged corner brick

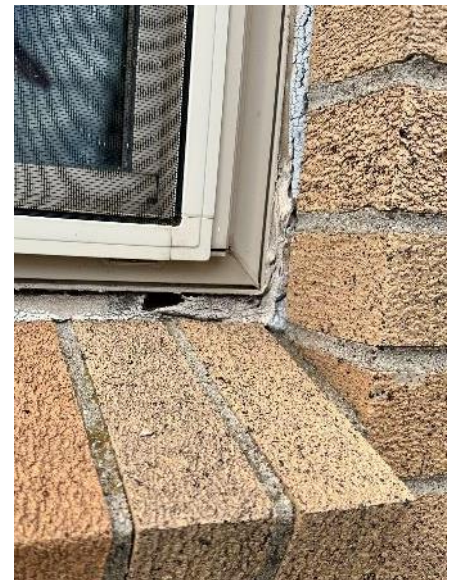
Deteriorated window sealant

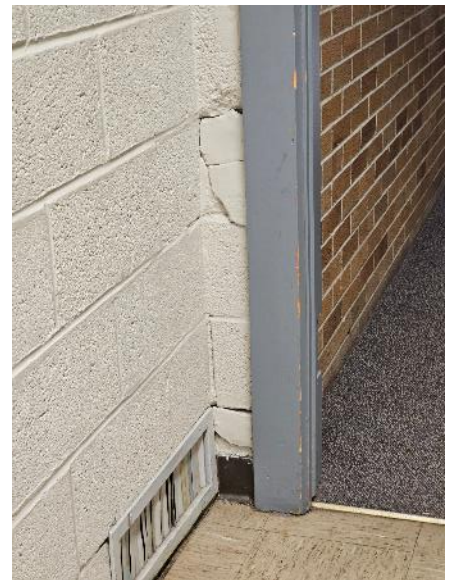
Cracking near interior hallway opening

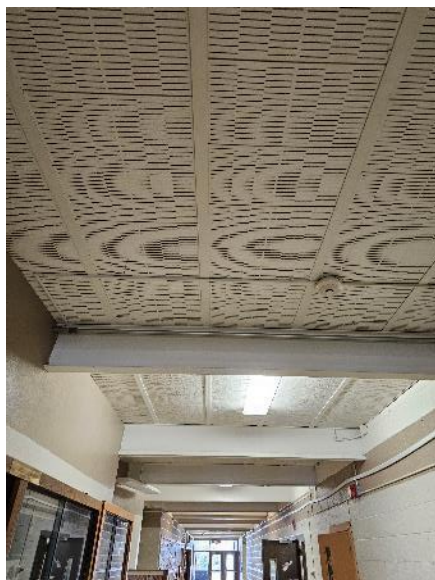
Adhered ceiling tile

Replace ceiling tiles as required.

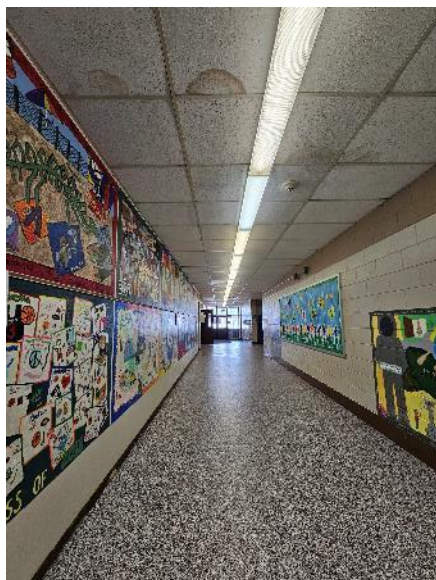
Water stains

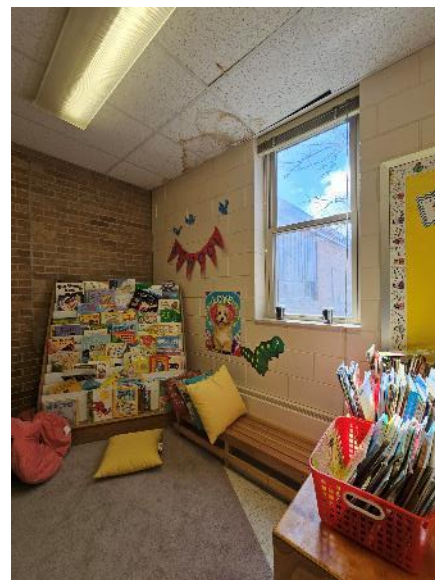
Water stains

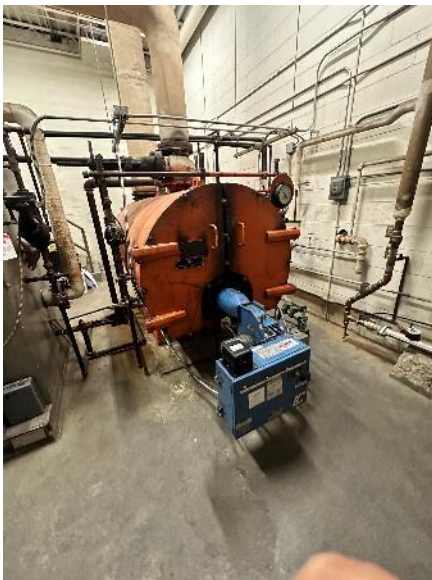
Fuel Oil Boiler

Remove steam boiler (electric and fuel oil) system, piping, traps, condensate, pumps, and controls. Replace with high efficiency hot water boilers, water piping, insulation, pumps, and controls.

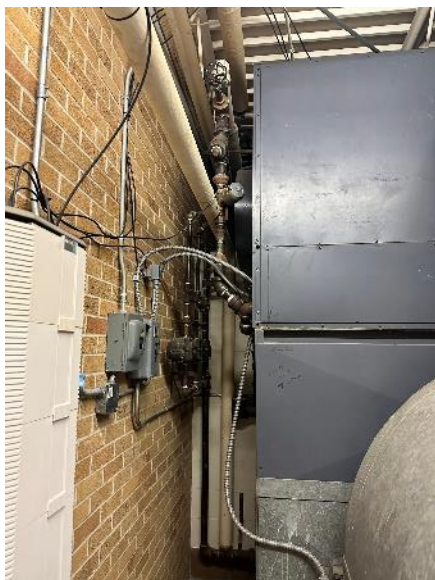
Steam distribution piping to AHU

Remove steam and condensate piping and replace with hot water hydronic piping, digital control valves, digital controls, and water treatment.

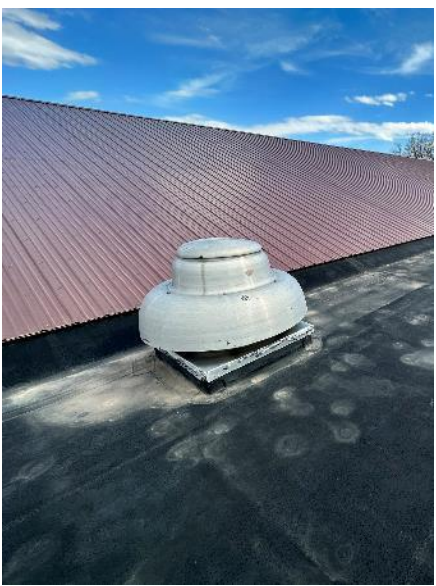
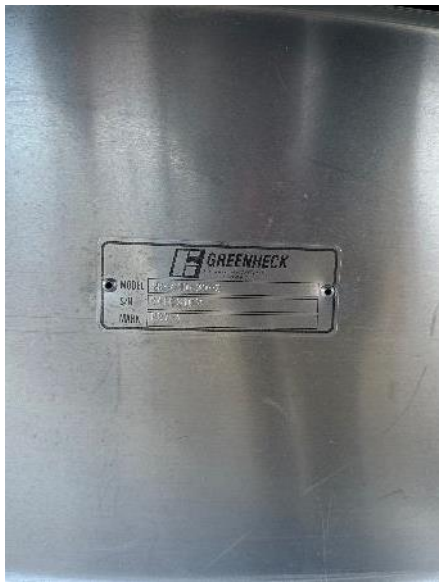
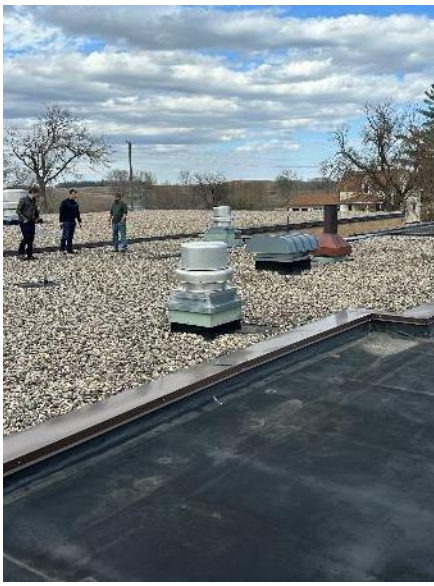
Power Roof Ventilators

For a well-designed HVAC system to operate correctly, Outdoor Air and Exhaust Air need to be working. The PRVs shall be replaced with new.

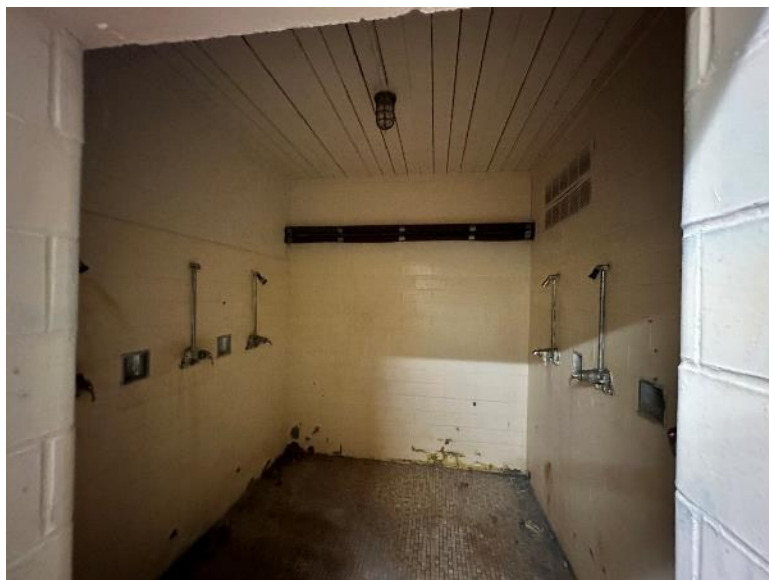
Unused showers

Budget for removal of fixtures. Cap plumbing lines at mains. Fill in sanitary drains and cap vents.

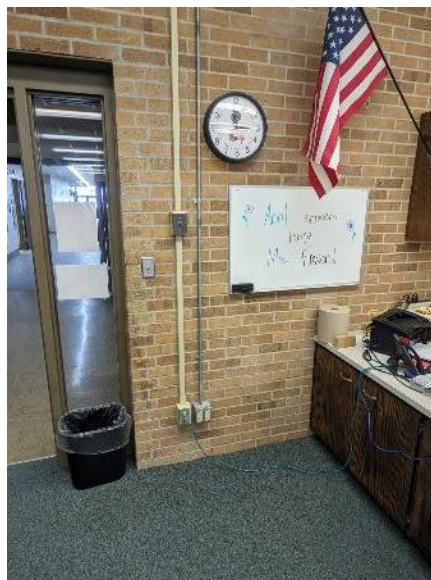
Examples of standard on/off switching in most locations.

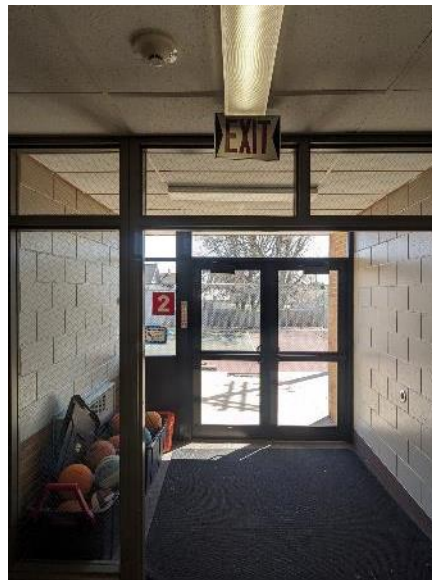
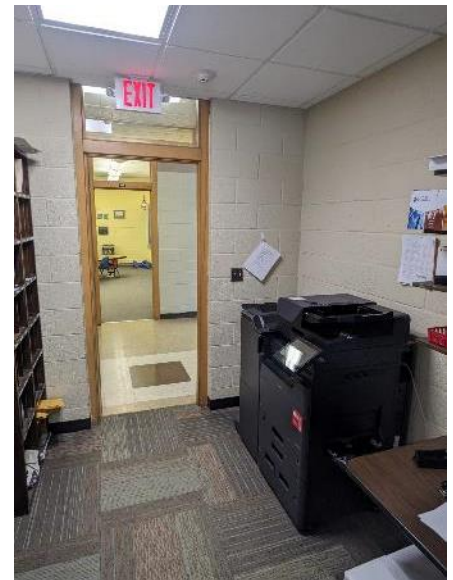
Examples of exit signs and emergency lights that require annual testing.

It is recommended to conduct annual testing of all powered exit sign and emergency lights, and repair and/or replacement of exit signs and emergency lights as needed.

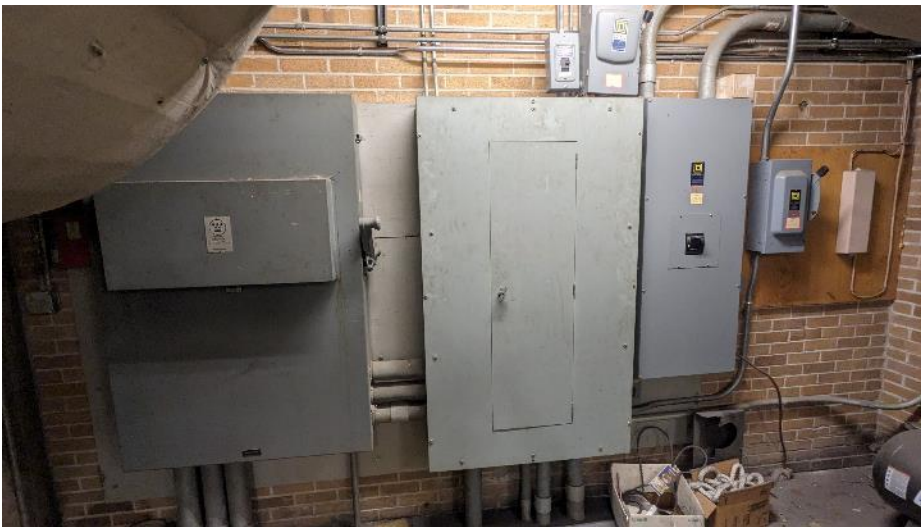
240V, 3-phase Service Disconnect (Far Left) and Distribution Panel (Center) – Both are Westinghouse branded equipment and should be replaced.

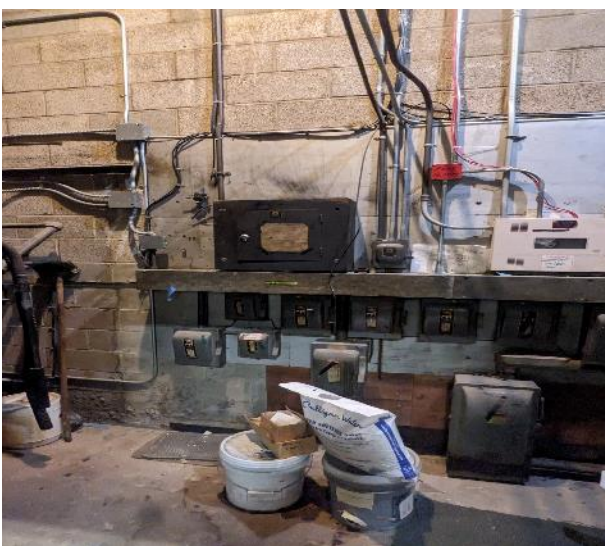
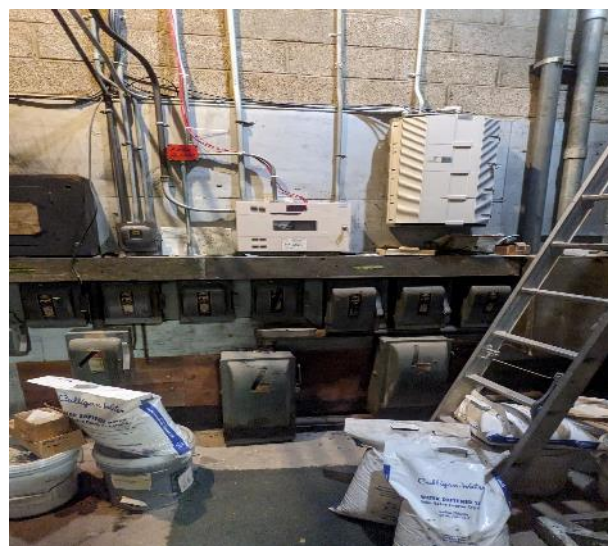
Square D Panel and Equipment Disconnects in Furnace Room 119.

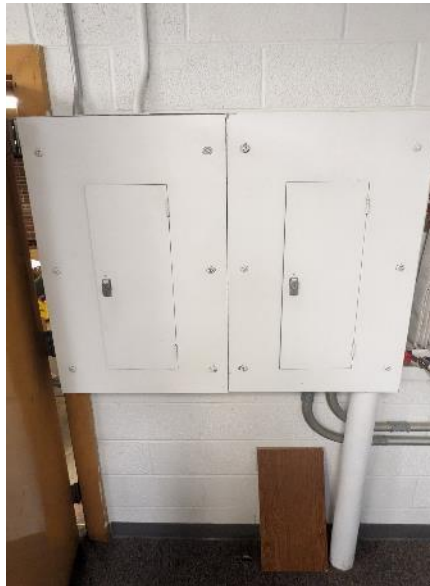
See below for photos of Westinghouse branded electrical panels that need replacement within the next 10 years.

Two Panels located in Custodial Office/Storage 117

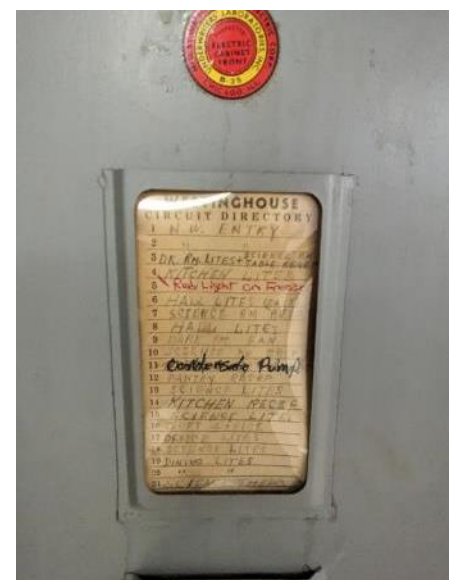
Examples of panels needing updated labels and circuit directories

It is recommended to hire an electrician to verify all the electrical loads in the building and provide up-to-date labeling and circuit directories for all the electrical distribution equipment.

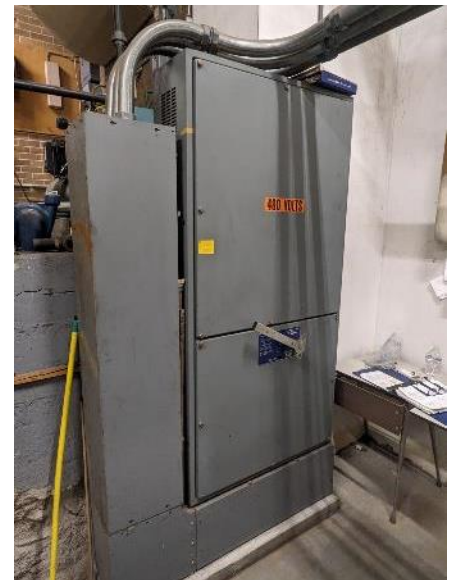
Examples of electrical equipment needing annual preventative maintenance

**ELO 5b** - Have electrical panels and distribution equipment cleaned. Dust build-up in panels can lead to nuisance tripping of circuit breakers, or even arcing and catastrophic failure in extreme cases.
