# West Central Area School District

Facility Assessment &  
Educational Adequacy Study

June 24th, 2024 - Final Report

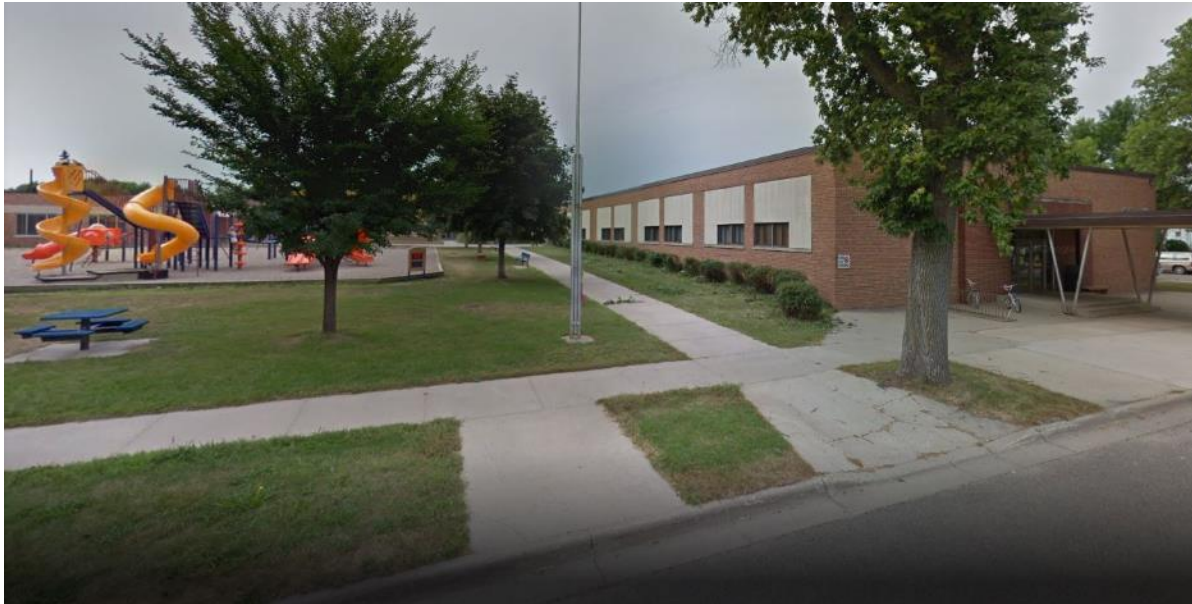
*\*North entrance- Not ADA compliant, no safe and secure access to building, not connected to administrative office, lack of signage or wayfinding, and no pedestrian crossing.*

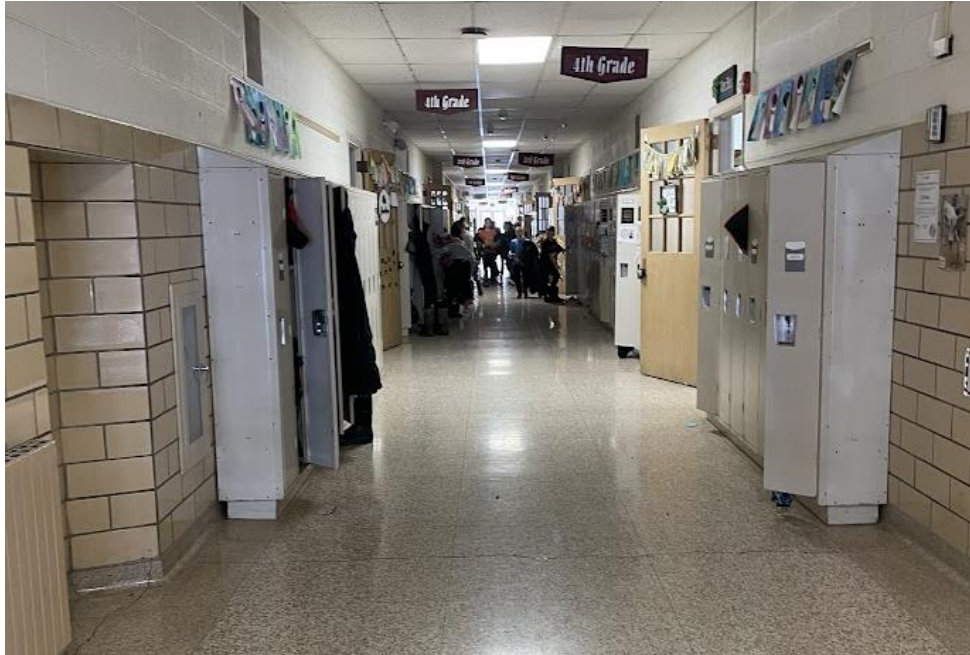
*\*Double loaded corridors, with lockers and poor sightlines and security.*

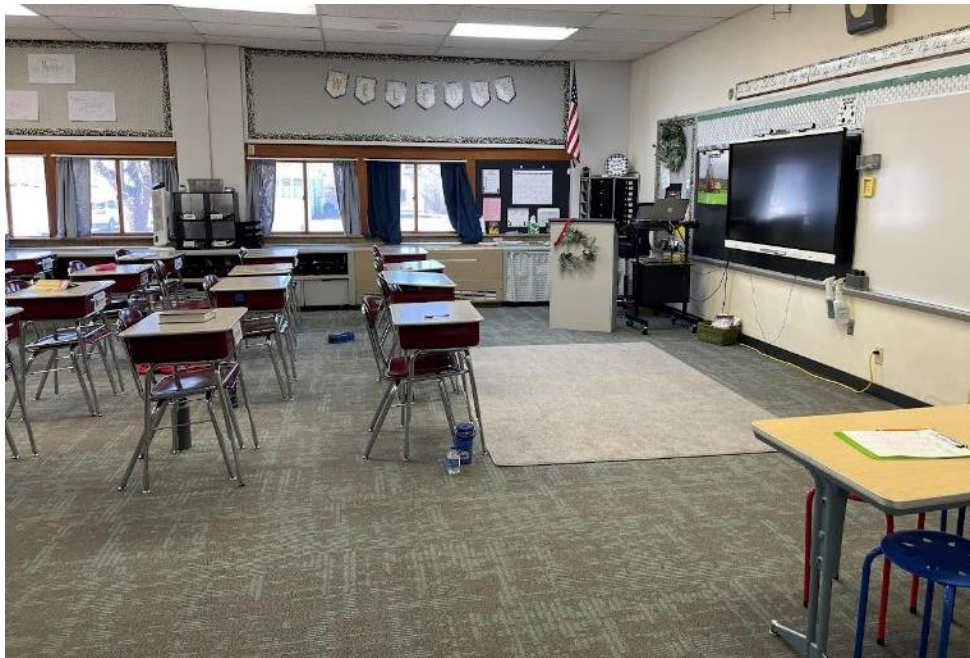
*\*Standard classroom with chalk boards, dated technology, limited access to power, and non-flexible furniture*

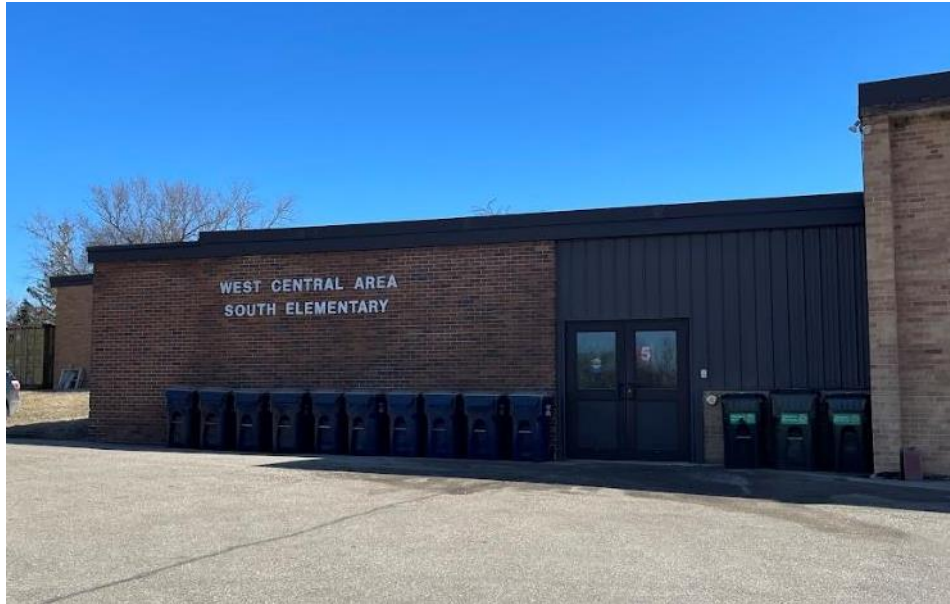
*\*West entrance- Not ADA compliant, no safe and secure access to building, and not connected to administrative office.*

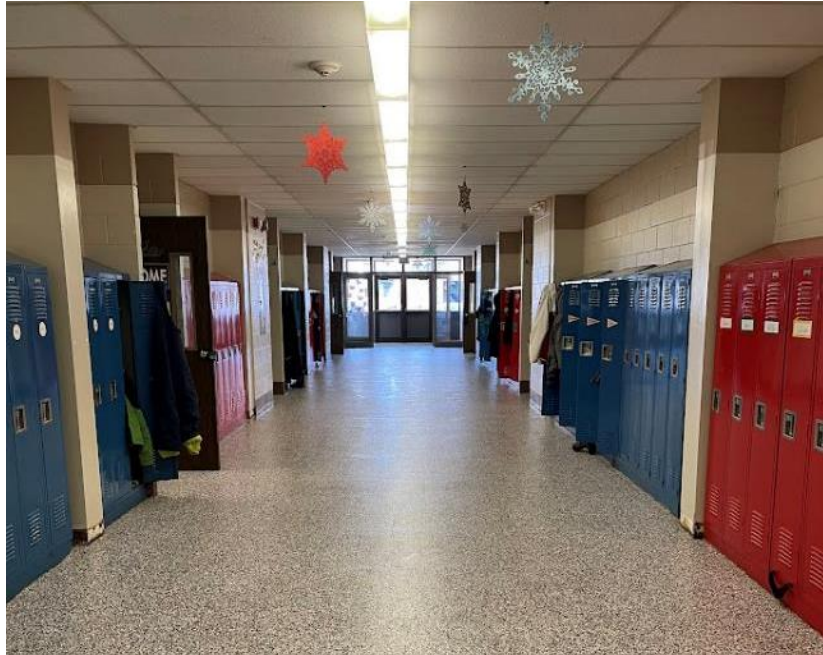
*\*Double loaded corridors, with lockers and poor sightlines and security.*

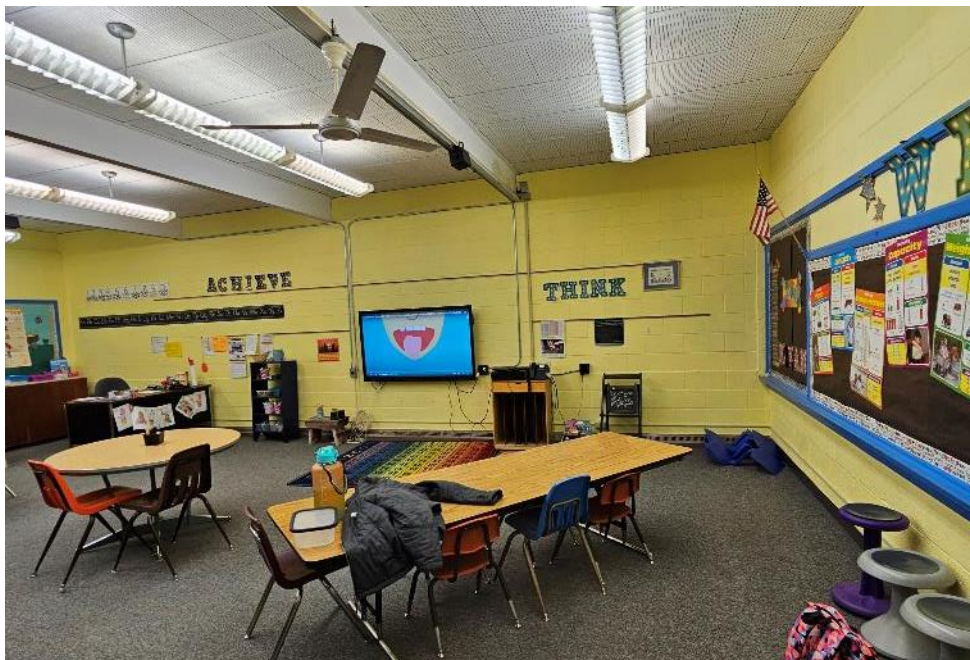
*\*Standard classroom with lack of white boards, dated technology, limited access to power, and non-flexible furniture*

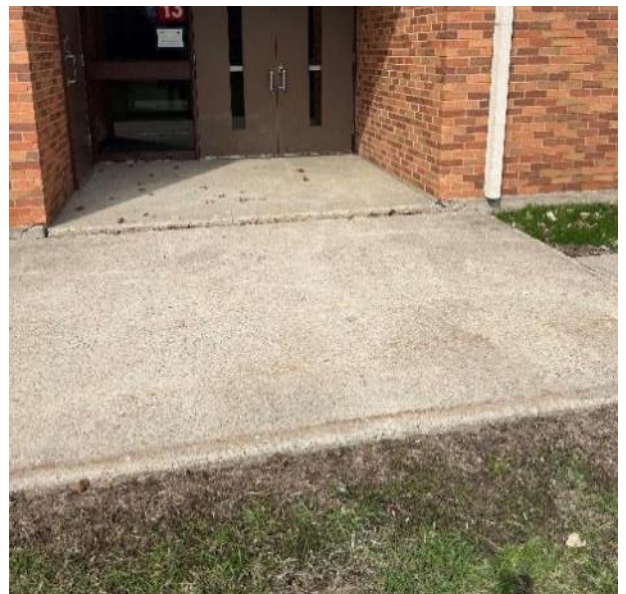
East building entrance (door 13).

The Elbow Lake facility, situated roughly in the center of the city, is notably in poor condition with several high-priority issues. Sidewalks are deteriorated and require replacement around the entire facility, including building entrances and stairways. The concrete curb and gutter has also deteriorated, necessitating a full replacement to restore proper functionality. The bituminous pavement throughout the parking lot is beyond repair and requires complete removal and replacement. Erosion caused by a roof downspout on the north side of the building has exposed the foundation, necessitating filling the area with concrete and installing a splash pad to prevent future erosion. Additionally, areas lacking sufficient grass coverage should be seeded and fertilized to promote turf establishment. To enhance drainage, the installation of storm sewers with area drain inlets is recommended. The basketball court bituminous pavement is in good condition today. It is recommended that the basketball court be reclaimed and paved in the future.

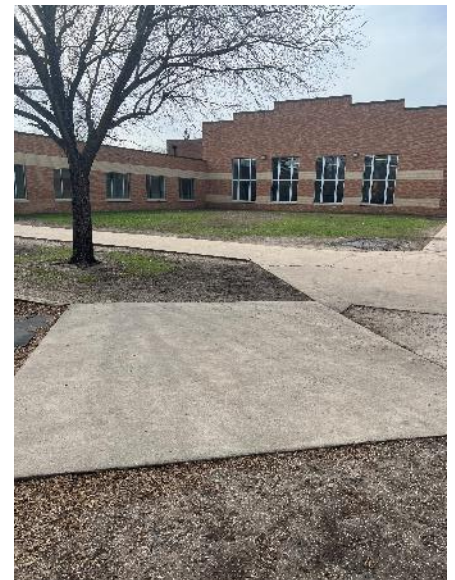
Drainage issues in green space.

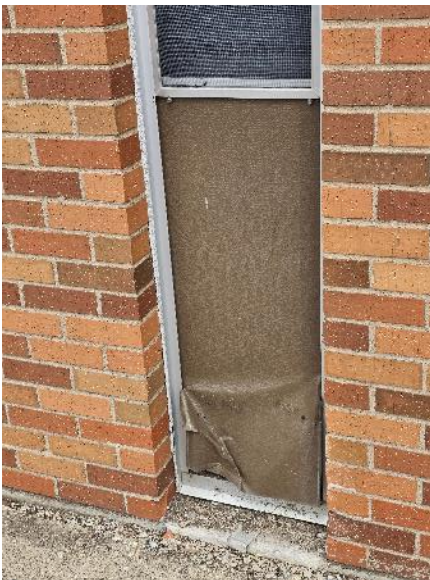
Broken window

Remove thermally inefficient existing windows and install new, thermally broken aluminum storefront windows and associated sealant, flashing and caulking. The new aluminum storefront windows will be energy efficient, prevent water and air infiltration into the building.

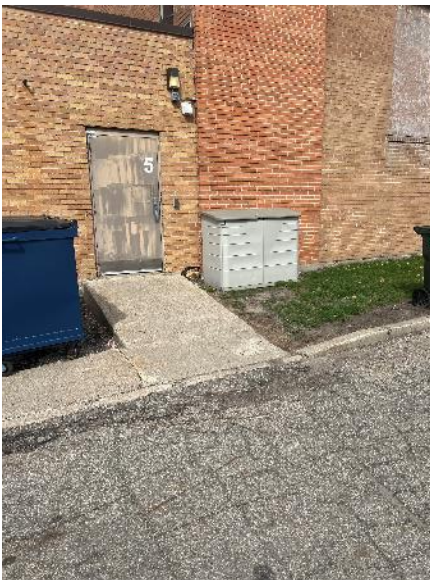
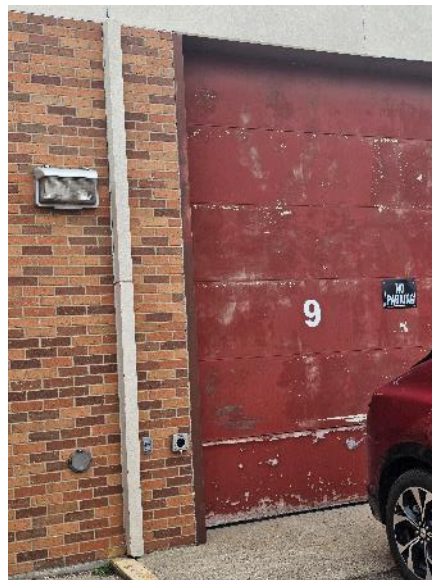
Exterior doors set into protective alcoves can continue to function adequately with routine maintenance to the finish paint, weatherstripping, seals, and sweeps. Doors with direct exposure will require additional maintenance routines as a result of UV related material degradation and freeze/thaw cycles.

Doors 5, 6, 9, & 10 need to be replaced.

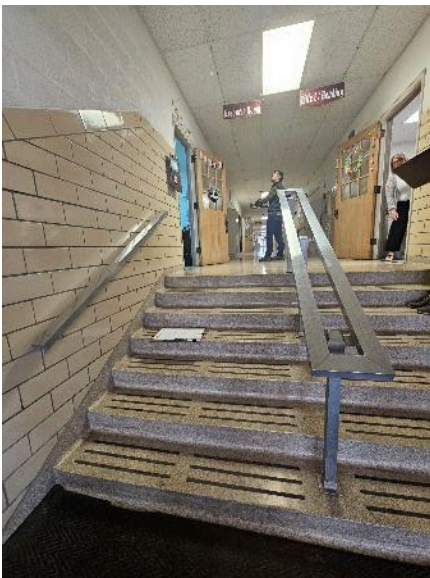
Non-compliant handrail extension

Update facility to meet all current Minnesota accessibility guidelines and building codes.

Minnesota Building Code requires a remodeling project expenditure of 20% of the construction budget for accessibility upgrades. For this reason, upgrades such as these should be looked at as part of any future addition/remodel project.

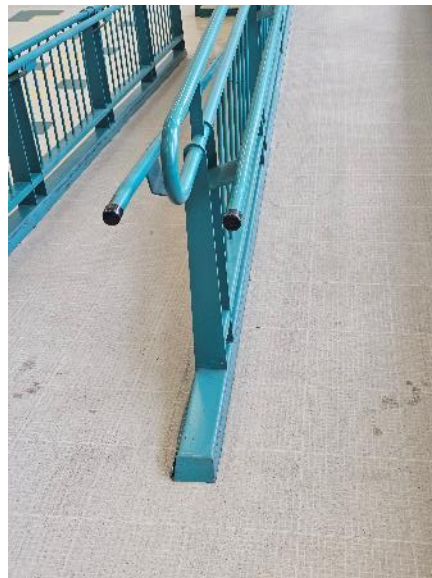
Non-compliant handrail extension

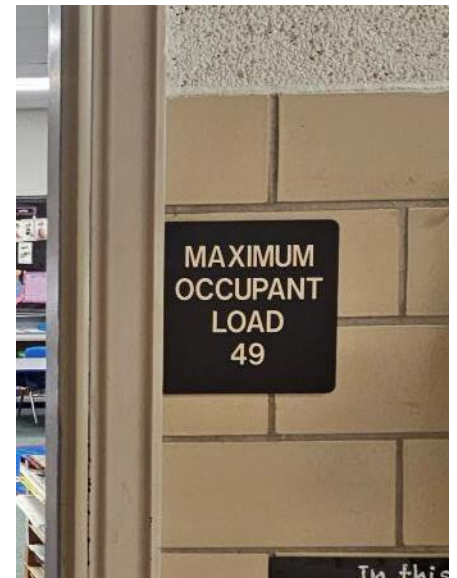
Non-accessible signage.

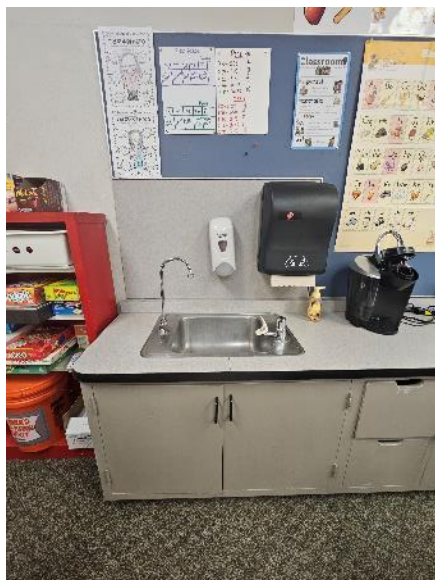
Non-accessible sinks & surface heights

Update facility to meet all current Minnesota accessibility guidelines and building codes.

Minnesota Building Code requires a remodeling project expenditure of 20% of the construction budget for accessibility upgrades. For this reason, upgrades such as these should be looked at as part of any future addition/remodel project.

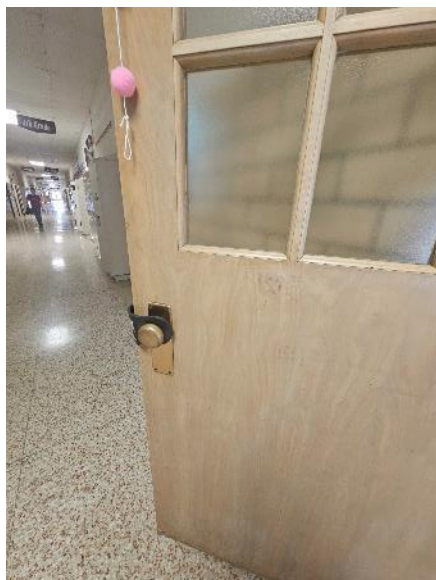
Non-accessible door hardware.

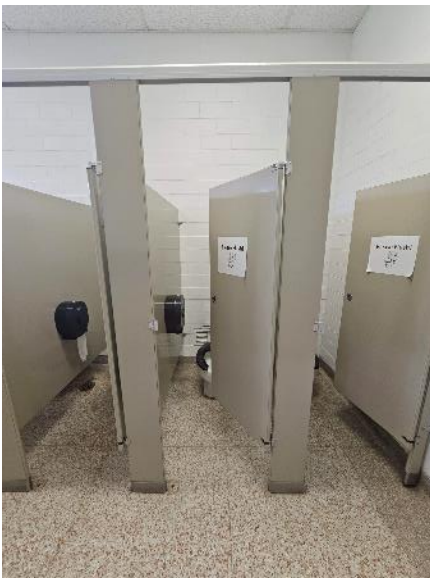
Stalls lack compliant floor space & grab bars

Restrooms throughout the building will need to be reconfigured to provide the adequate clearance at entry doors, around plumbing fixtures and within toilet stalls, as defined by the current Minnesota Accessibility Code. This reconfiguration would require a remodel and would impact the overall layout of the interior space of the building, including the relocation of the plumbing fixtures. In addition, the current Minnesota State Building Code requires impervious flooring materials and wall base, as well as cleanable wall finishes and ceiling materials. These items would be taken into consideration in a full restroom remodel.

Minnesota Building Code requires a remodeling project expenditure of 20% of the construction budget for accessibility upgrades. For this reason, upgrades such as these should be looked at as part of any future addition/remodel project.

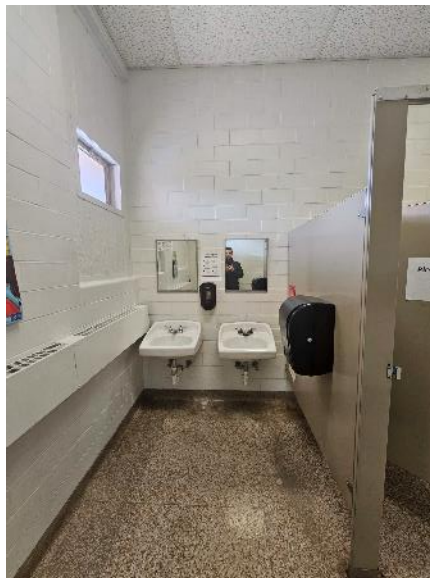
Sink locations lack compliant floor space, height requirements, and operable control requirements

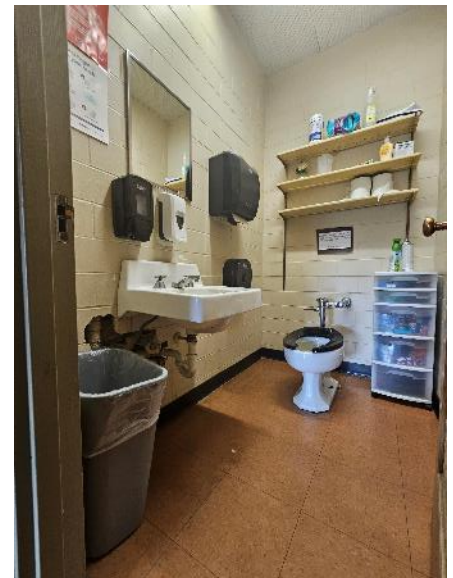
Refer to previous

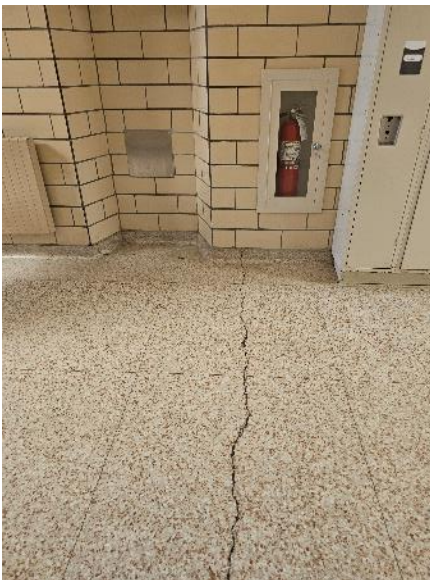
Cracking across hallway

Create a routine maintenance plan to perform annual inspections for the purpose of locating and identifying specific instances of cracking. Patch and repair as required.

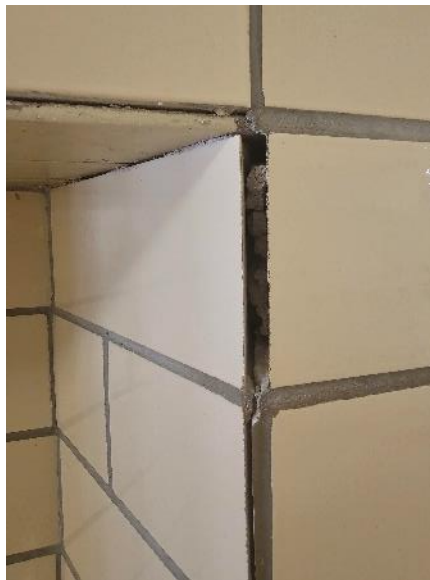
Damaged wall tile grout

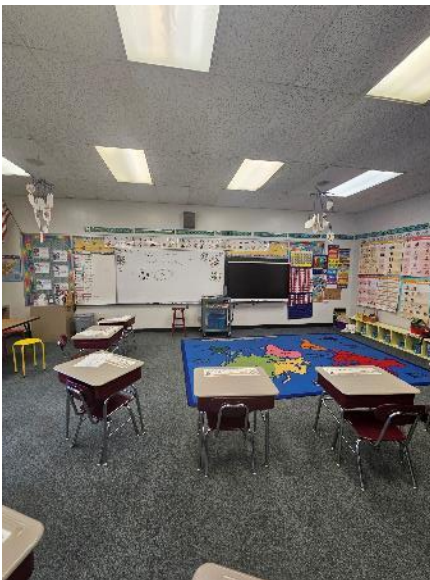
Classroom & Library flooring is primarily a single roll carpet that remains in good condition but will require replacement within the +/- 5-8 year range, with a few rooms requiring earlier replacement. Wall finishes did not show significant damage that would require major repair work, however there are areas that require patching and painting.

Typical classroom carpet

There is a mix of newer carpet tile selections and older roll-type carpet selections. Preparations should be made for planned upgrades to the older selections.

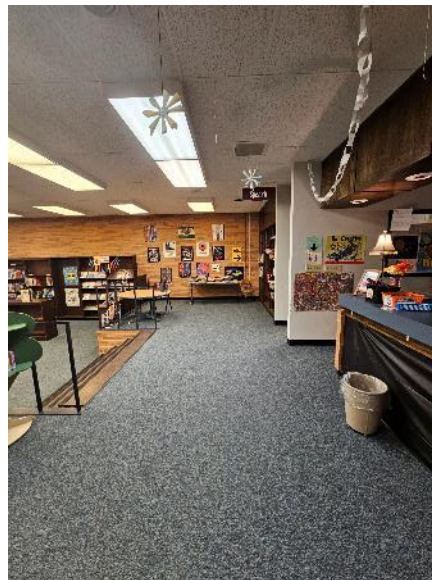
Typical library carpet

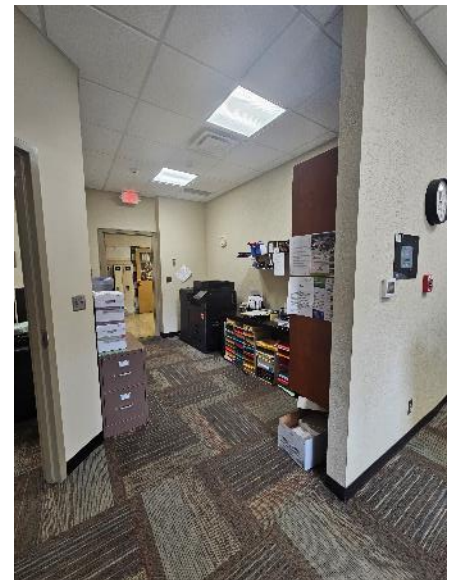
Typical administration carpet

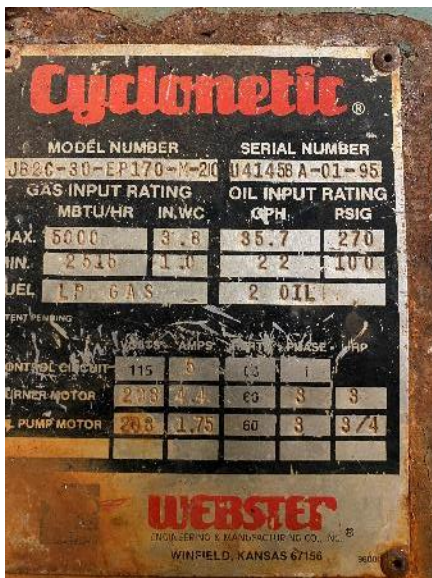
The building's steam distribution system is served with two 5,000 MBH, liquid propane with fuel oil backup boilers. These boilers are 29 years old and beyond their useful life. Maintenance and repairs are available for these boilers to keep them useful but come at a sizeable cost and is not a long-term fix.

Steam Boiler tag

Remove steam boiler system, piping, traps, condensate, pumps, and controls. Replace with high efficiency hot water boilers, water piping, insulation, pumps, and controls.

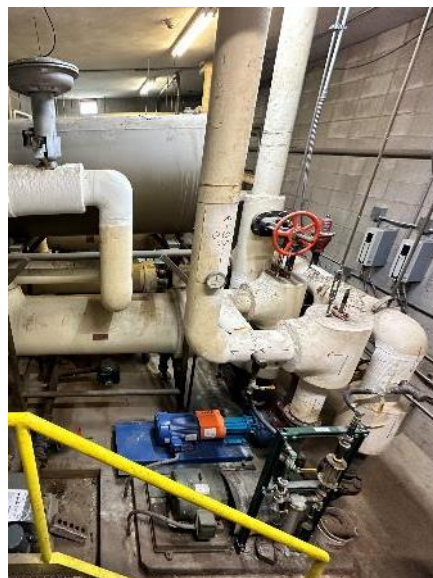
Steam to Hot Water Exchanger

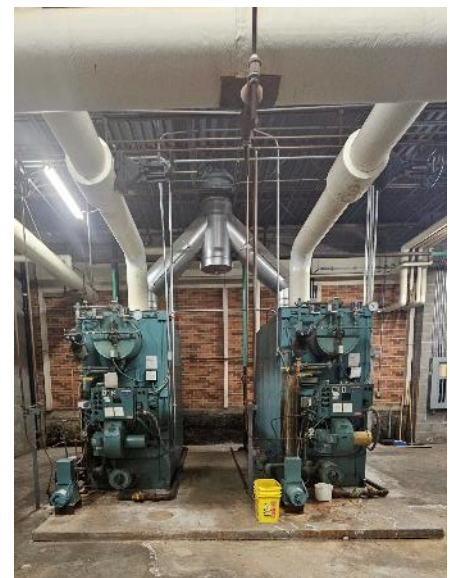
Steam Boilers

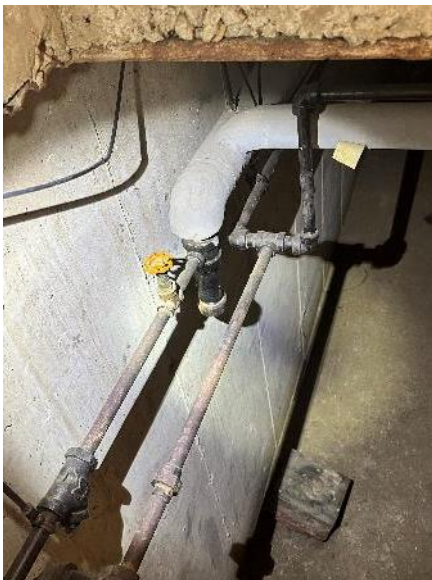
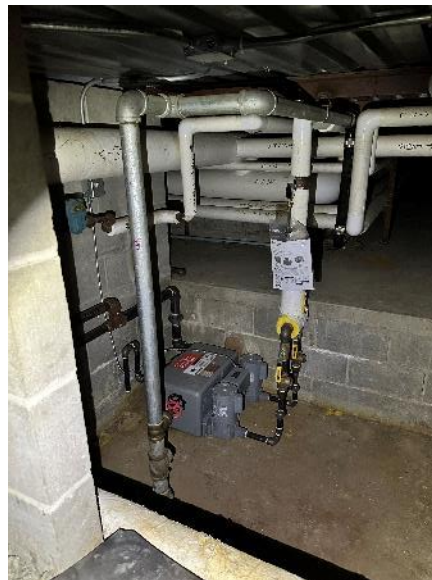
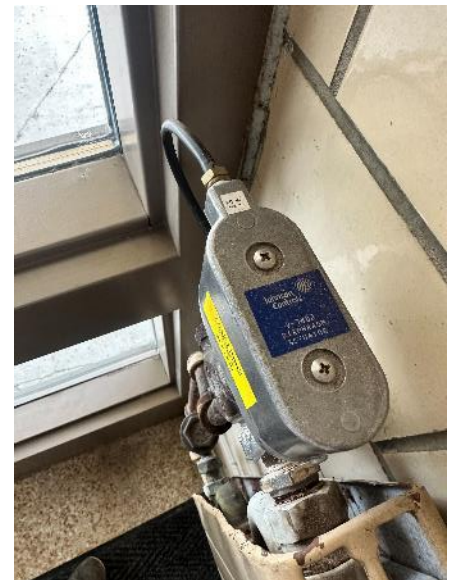
The building's steam distribution system is of the age where it has or will start to fail. A leaking steam pipe to one of the wings could result in inability to heat, school shutdowns, and possible damage to water lines if not addressed right away (like over a weekend). Fixes for the initial leaks might last but additional failures are likely.

Remove steam and condensate piping and replace with hot water hydronic piping, electric control valves, digital controls, and water treatment.

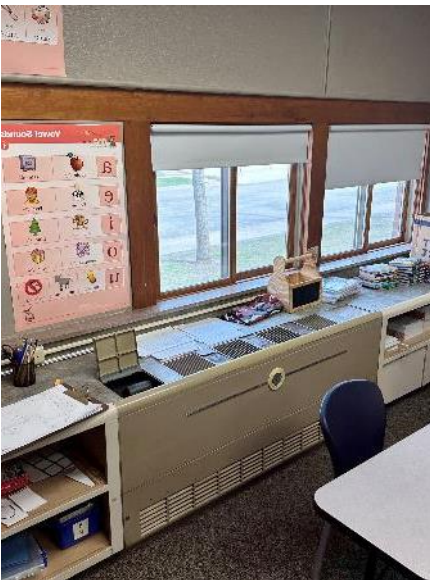
The classroom steam terminal units consist of unit ventilators and a steam radiator. Most unit ventilators are not operating at 100%. They are beyond the age where they have failed or will start to fail (heat exchangers/ motors/ OA dampers). There is either a reduction of fresh air per classroom or too much where energy is wasted.

Classroom Unit Steam Ventilator

Remove steam unit ventilators, radiators, piping, valves, and controls in classrooms throughout west side (steam side) of the elementary.

Replace with hot water fin tube radiation, hydronic piping, electric control valves, digital controls, and water treatment for envelope losses as needed in Vestibules or corner rooms.

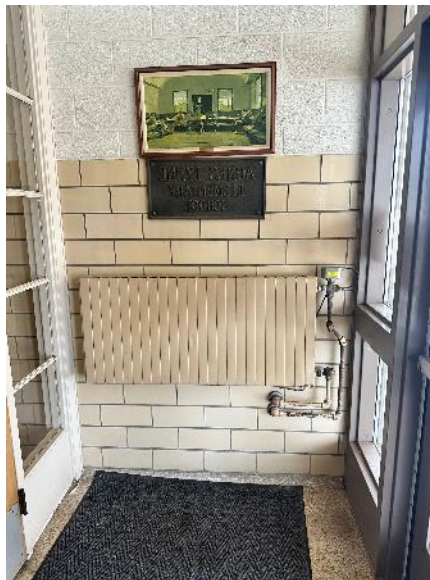
The building's steam radiators in Hallway and Vestibules are technically beyond useful life but still operational. Efficiency is questionable as the steam radiators may be scaled and in need of water treatment or beyond repair. These units are not able to be used when converting to hot water hydronic systems and will need to be replaced.

Vestibule Steam Radiator

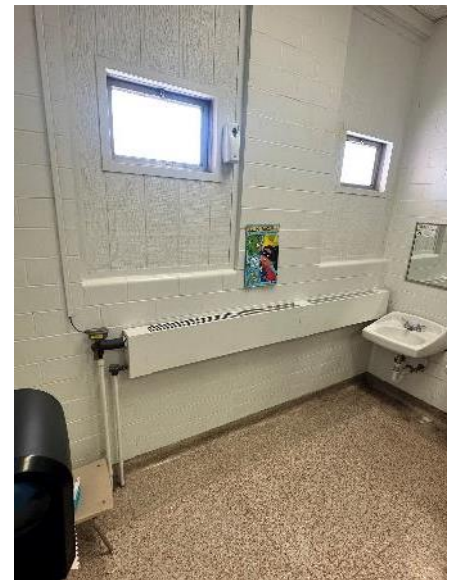
Restroom Steam Radiator

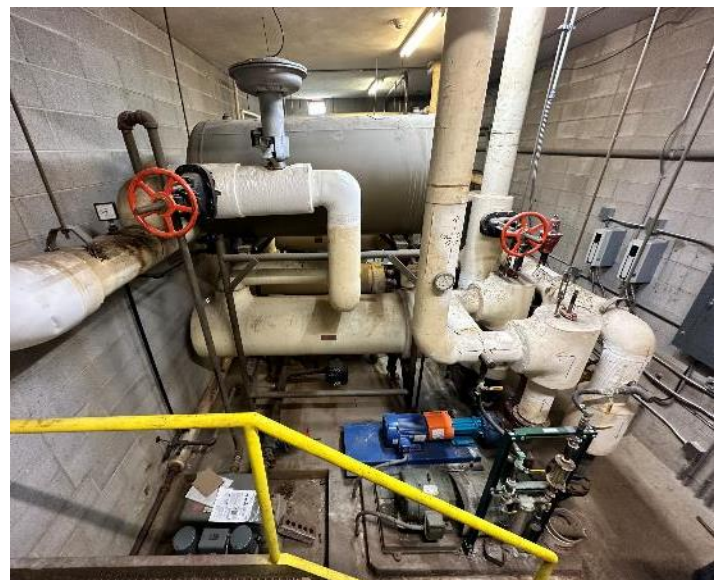
Steam to Hot Water Distribution / Pumps

Budget for removal of Shell and Tube Exchanger and circulating pumps with the upgrade to hot water boilers. Replace current water/ auto antifreeze and replace with proper glycol / water percentages.

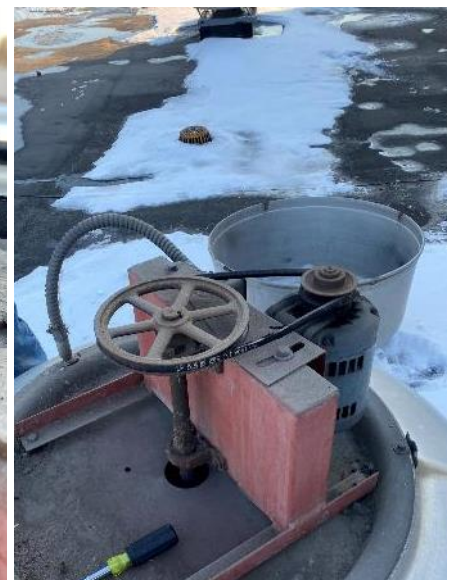
PRV – Maintenance Required

For a well-designed HVAC system to operate correctly, Outdoor Air and Exhaust Air need to be working. The PRVs shall be replaced with new as they are not worth repairing. Exhaust fans shall be designed with direct drive motors to reduce maintenance time and costs.

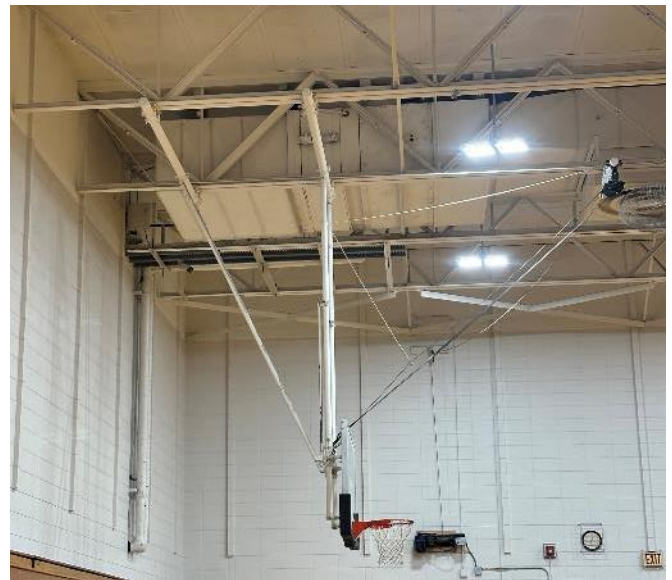
The east portion of the building and gymnasium is served by five AHUs (three serving classrooms and two for the gymnasium) which provide heating and ventilation (fresh air). The units and controls are beyond their useful life and require significant effort to keep up with maintenance and repairs. These units have Hot Water coils, constant speed fans, and pneumatic controls. They don't have cooling coils or have the ability to add cooling.

Indoor AHU – Heating Only

The AHUs are operational for now but should be replaced with upgraded systems which employ more efficient technologies such as variable speed fans, digital controls, and more accurate outdoor air measures. The replacement units can be mounted in place or on the roof to gain more storage if needed. The new units shall be sized with cooling / dehumidification. A unit shall be added for the west wing and incorporate ductwork to each classroom with a VAV system with hot water reheats.

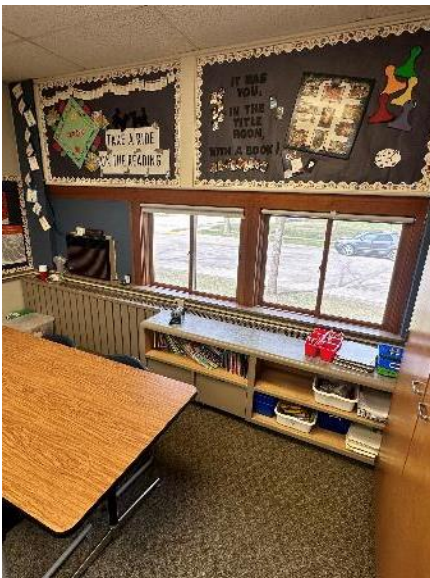
Through-Wall Air Conditioning Units used for classroom and spot cooling are outdated and not operational. The units are past their useful life and do not meet MN energy Code for efficiency.

Through wall AC unit

Remove through-wall air conditioners and patch walls to match existing. New HVAC system shall provide cooling.

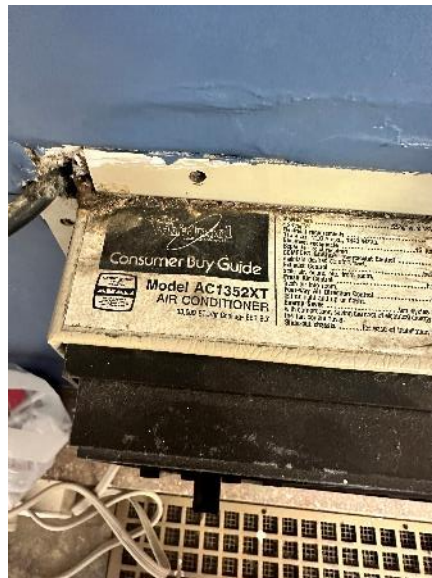
AC Unit Model Number

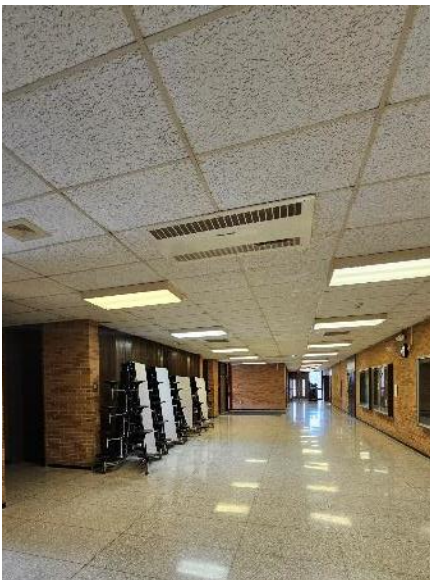
Recessed Ceiling Heater - Lobby

Provide thorough maintenance and replace fan motors if needed.

In the next 10+ years, remove these heaters and replace with individual AHUs or RTUs for spaces needed. New units will have air-conditioning / dehumidification. New units will also meet the proper energy code for heating, cooling, and fan efficiencies which will provide savings in utility bills.

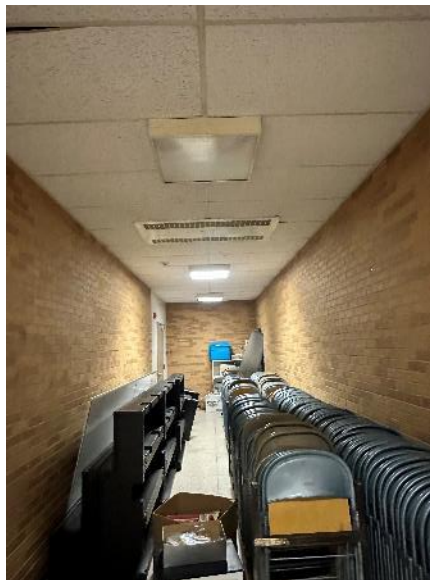
Recessed Ceiling Heater – Storage

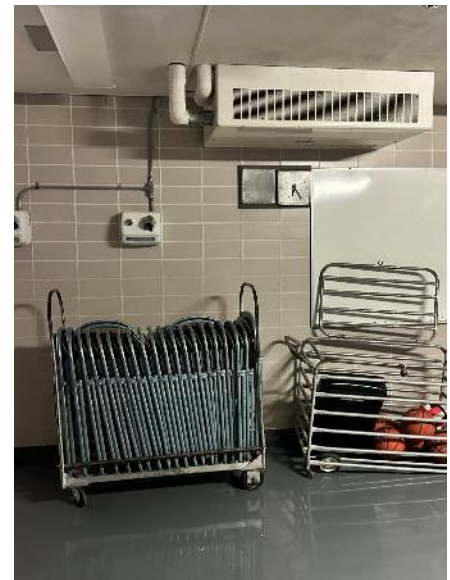
Flush Mount Ceiling Heater - Lockers

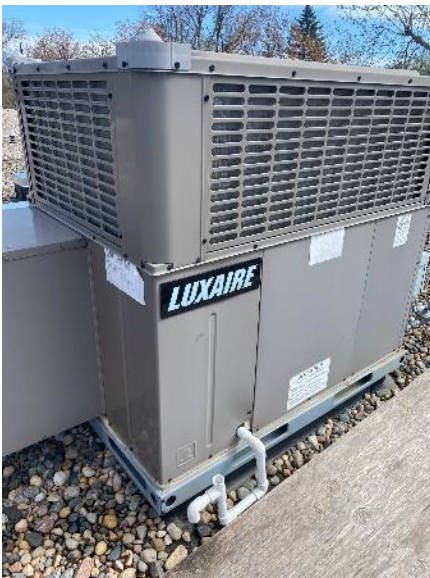
Office RTU

The 2005 RTU is just beyond its life expectancy and shall be budgeted for replacement in the next 1-5 years.

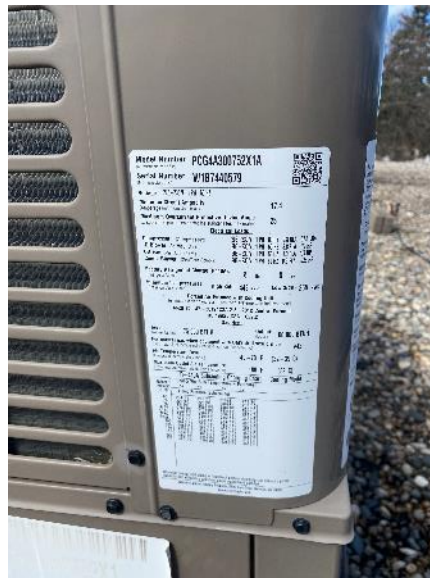
RTU information

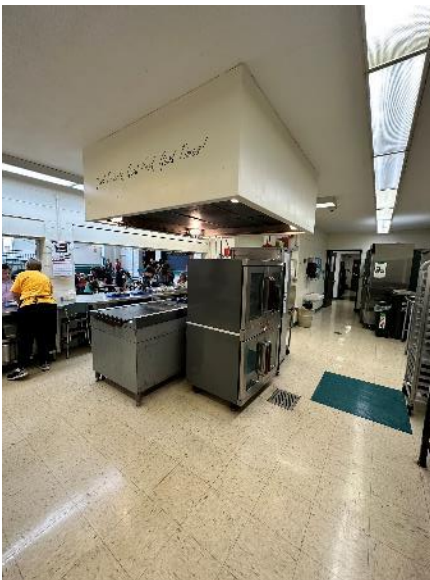
Type-1 Hood

Budget for replacement of kitchen HVAC system in the next 6-10 years. Type-1 and 2 hoods, exhaust fans, fire suppression, and make up air unit. Investigate layout and consider relocating sinks and cooking equipment in the most efficient manner. Route piping in walls, upgrade hand sinks to stainless steel. Upgrade Water heater a gas-fired unit. Add recirculation pump.

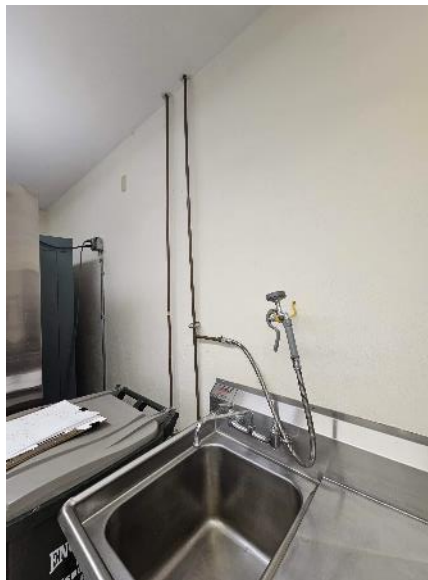
Reroute and insulate water lines.

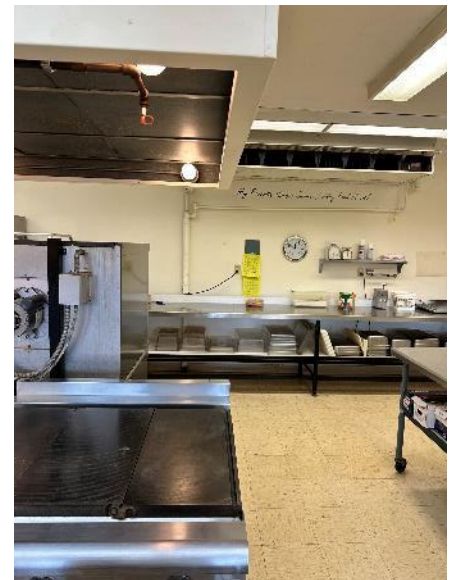
Griddle is outside of Type-1 hood.

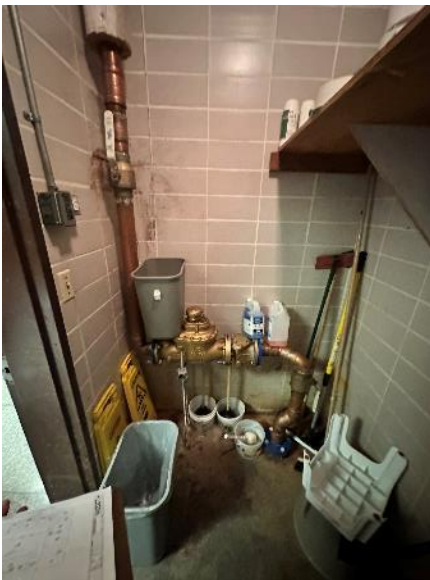
Overall, the plumbing fixtures are operational but need updating. There is a new water meter because the old one was unable to shut down, which is a telling sign of the rest of the building. Locker rooms seem to be used for changing and restrooms only. Unused for showering. Building has a mix of flush valve and tank-type water closets. Some of the fixtures are starting to show wear and hairline cracking. Classroom sinks do not meet code (bubblers).

Replaced water service

Replace faucets on lavatories and sinks. Replace flush valves and water closets and urinals. Replace necessary fixtures with matching equipment. Budget for replacement of all fixtures within the next 10 years.

Replace all domestic water lines throughout the building to each fixture group with copper piping.

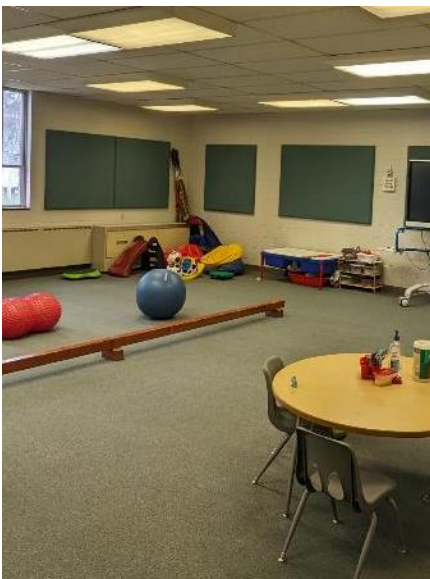
The classroom relies on hot water radiation and unit ventilators for heat. There is minimal ventilation and no air conditioning. The unit ventilators are beyond the age where they have failed or will start to fail (heat exchangers/ motors/ OA dampers). There is either a reduction of fresh air per classroom or energy is wasted (too much OA) when using the ventilators.

ECCE – Unit Ventilators

Remove and replace unit ventilators with an AHU or RTU to serve the spaces with proper heating, cooling, and ventilation for the purpose used.

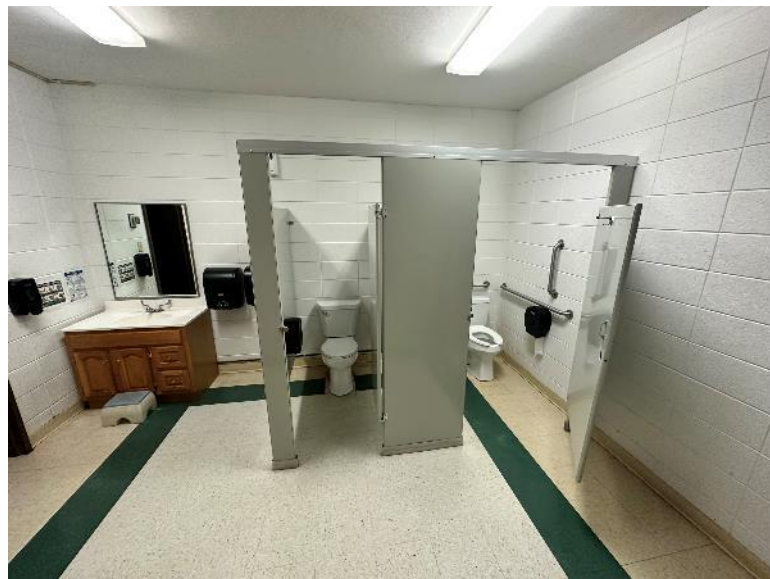
Restroom fixtures

Budget for repair and/or replacement of plumbing fixtures in the boy's and girl's restrooms within 6-10 years. Consider new 10" water closets and lower wall-hung lavatories for the younger children.

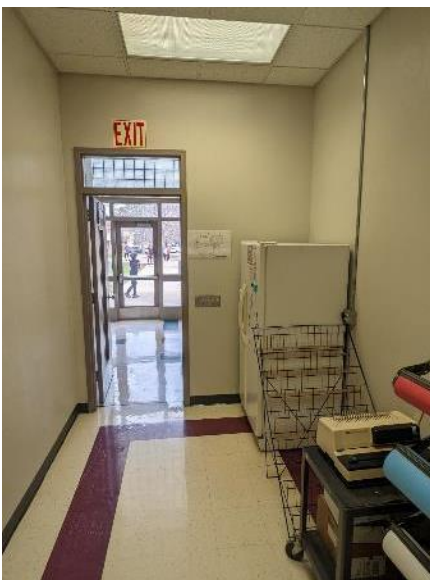
Following is a list of non-illuminated exit signs observed during walkthrough:

- Teacher's Lounge 19W (total of 2)

Non-Illuminated Exit Signs in Teacher's Lounge 19W

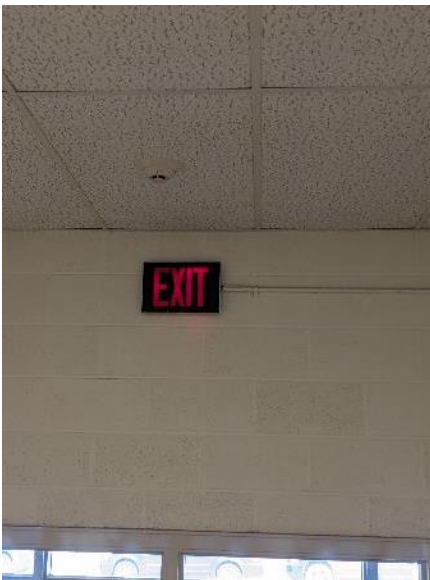
Examples of exit signs and emergency lights that require annual testing.

It is recommended to conduct annual testing of all powered exit sign and emergency lights, and repair and/or replacement of exit signs and emergency lights as needed.

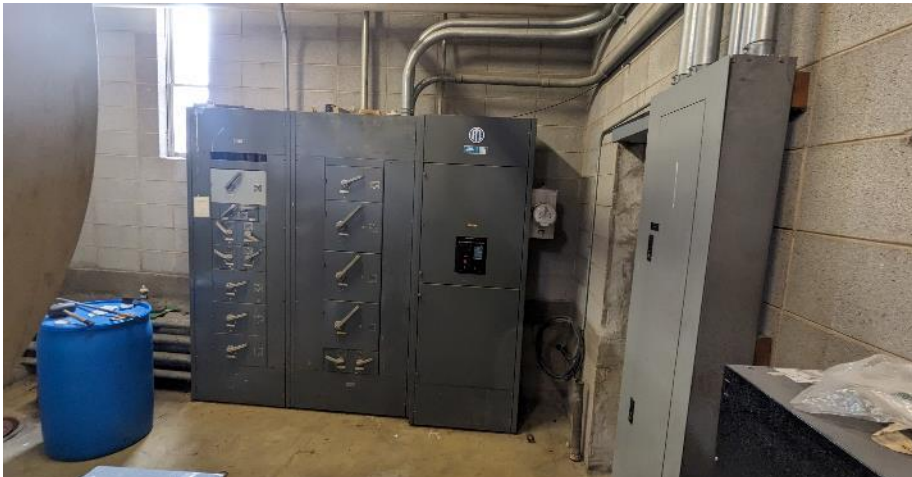
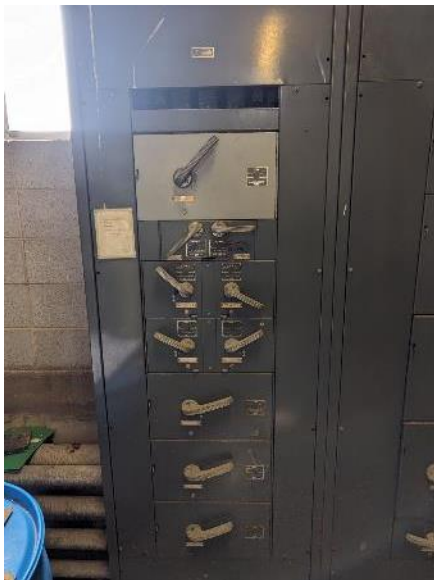
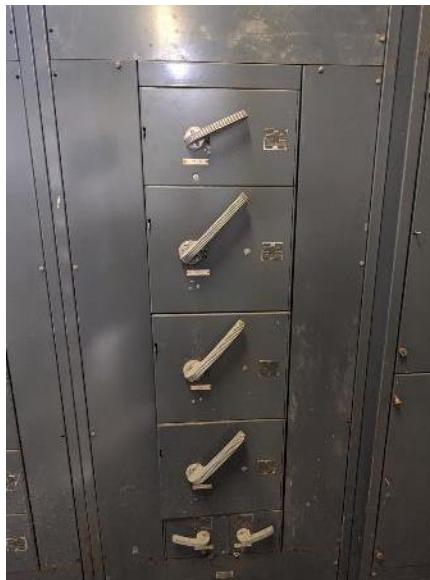
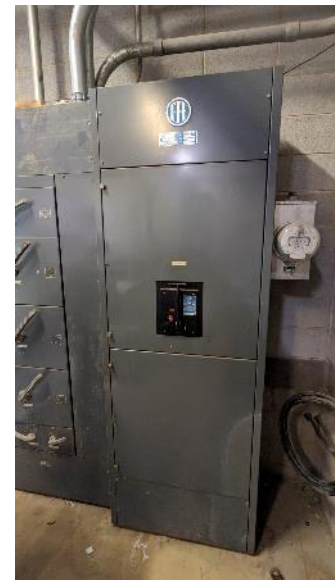
#### ELO3a:

See below for photos of existing 2000A ITE Switchboard, in need of replacement within the next 15 years.

Existing 2000A ITE Switchboard for Electrical Service Entrance

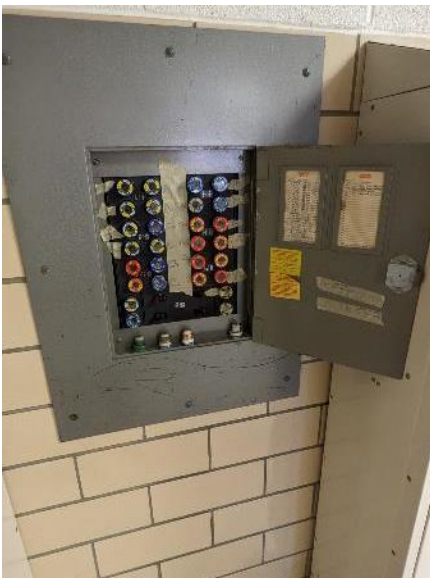
**ELO3b:**

See below for photos of fuse-style electrical panels that need immediate replacement.

Panel in Corridor outside Classroom 5W

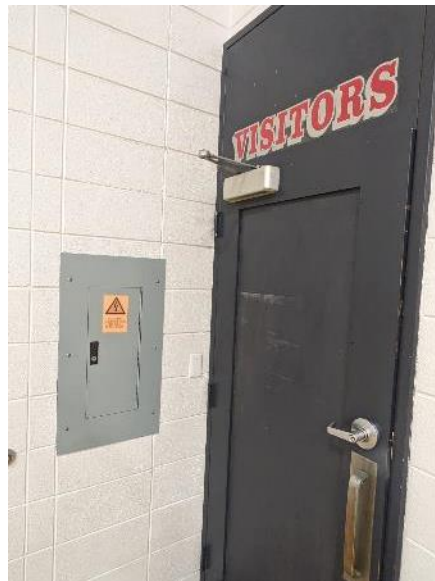
Panel B in North Wall of Gymnasium 14E

See below for photos of ITE branded panels in need of replacement within the next 10 years.

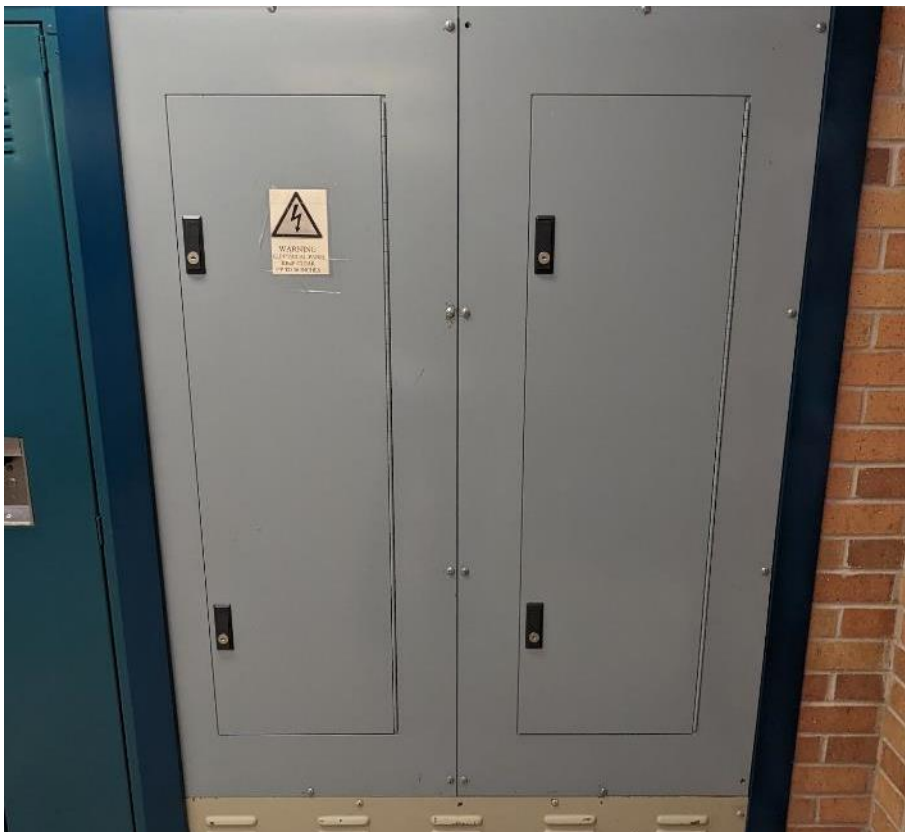
Double-tub Panel in Corridor 136A outside Classroom ECFE 5E

See below for photos of ITE branded panels in need of replacement within the next 15 years.

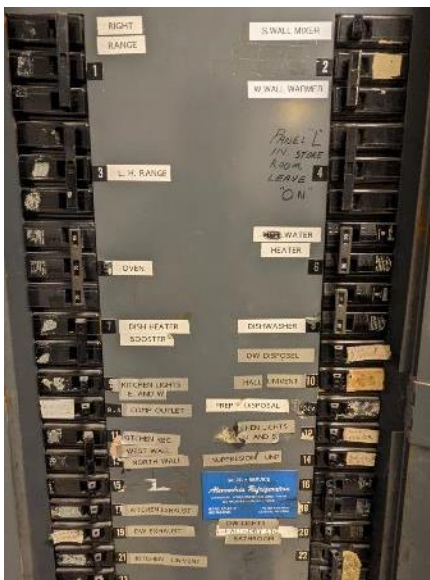
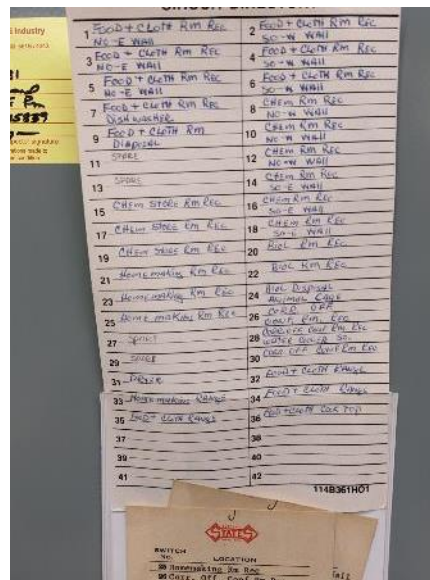
The electrical distribution equipment labels, and the electrical panel circuit directories are largely out of date, labeled incorrectly, and in some cases completely absent or unreadable. This creates confusion for future remodels, and potentially unsafe conditions for personnel during emergencies or maintenance and repair work.

Examples of panels needing updated labels and circuit directories

It is recommended to hire an electrician to verify all the electrical loads in the building and provide up-to-date labeling and circuit directories for all the electrical distribution equipment.
