# West Central Area School District

Facility Assessment &  
Educational Adequacy Study

June 24th, 2024 - Final Report

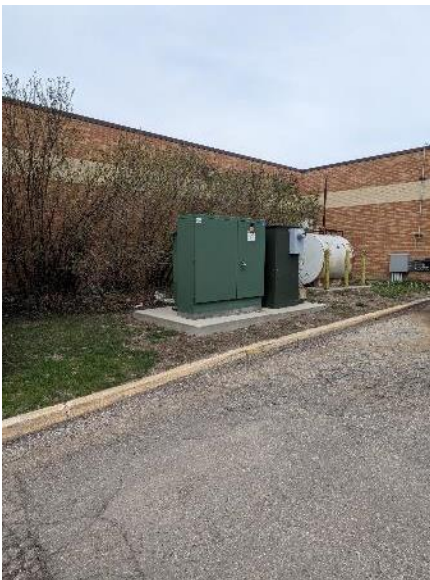
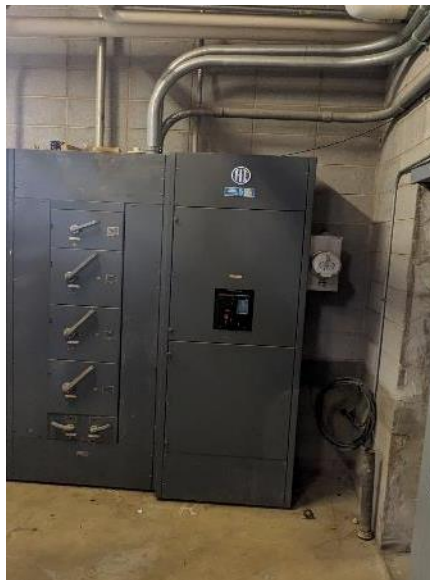
Examples of electrical equipment needing annual preventative maintenance

**ELO 5a** - Have thermal testing conducted on all electrical distribution equipment (ie: transformers, metering cabinets, panels, disconnects, VFD's, etc.). This can help find loose connections, detect overloaded circuits or potential failure points that could lead to costly equipment damage and/or injuries to personnel.

**ELO 5b** - Have electrical panels and distribution equipment cleaned. Dust build-up in panels can lead to nuisance tripping of circuit breakers, or even arcing and catastrophic failure in extreme cases.

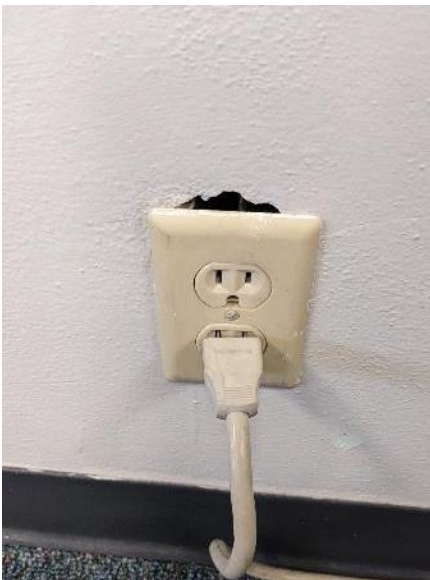
1. A receptacle on the north wall of Kindergarten 1yW has a sizeable gap in the wall above the receptacle, leaving exposed wire accessible. This poses a shocking hazard, especially to young, curious children with small hands.
2. A receptacle in Janitor's closet opposite Classroom 9W does not have GFCI protection. With the potential exposure to water in this room, this poses a potential shocking hazard to maintenance personnel.

Receptacle in Kindergarten 17W

**ELO 8a** – Patch and repair wall above receptacle so that there is no gap or access to exposed wires.

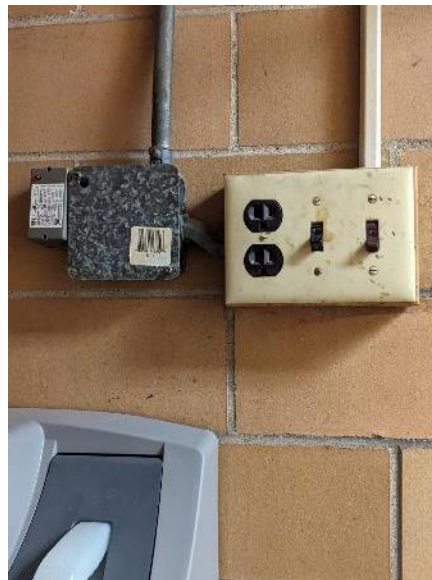
Non-GFCI Receptacle in Janitor's Closet

**ELO 8b** – Replace receptacle with new integral GFCI device.

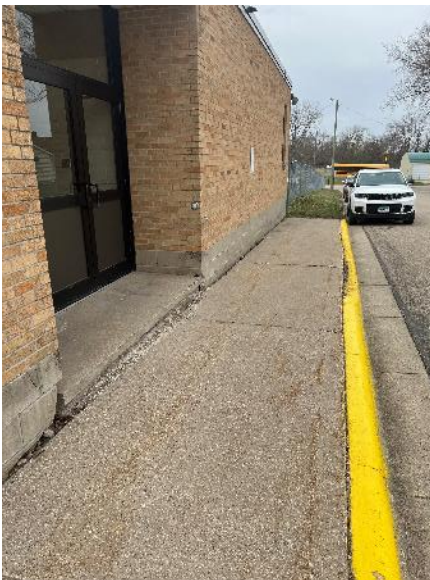
Portions of the existing sidewalks and stairways do not meet American with Disabilities Act (ADA) standards. Trip hazards, inconsistent stair riser heights, and inadequate handrails pose safety risks to students, staff, and visitors. The sidewalks show signs of wear, including cracks, and settlements. The facility has a pedestrian crossing at CSAH 1 that shares the parking lot entrance. The pedestrian crossing and parking lot entrance should be separate.

North entrance.

It is recommended that all the existing, non-ADA compliant concrete sidewalks be replaced with new, ADA-compliant structures. The parking lot entrance should be moved to separate the pedestrian crossing and the parking lot entrance.

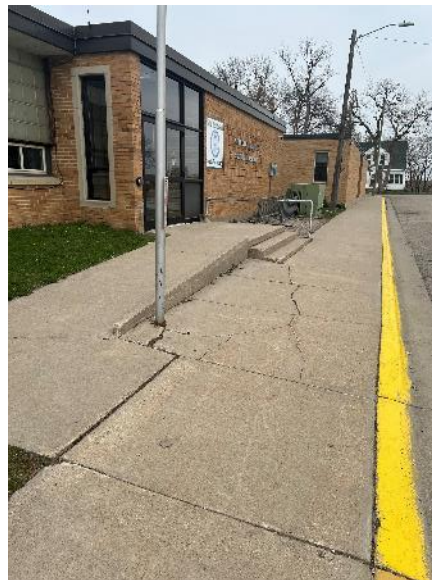
East entrance.

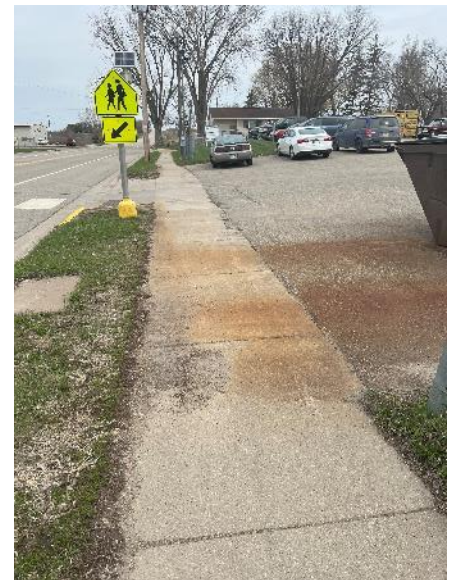
Shared pedestrian crossing and parking lot entrance.

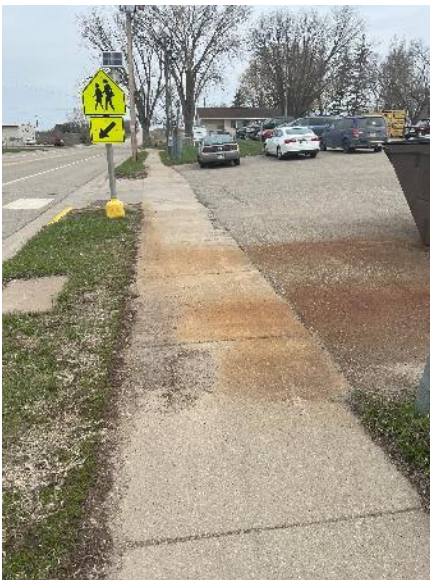
The bituminous pavement in the parking lot is in good shape. The parking lot has very little cracks present. The bituminous trail around the facility is also in good condition.

Parking lot entrance along CSAH 1.

1. Annual crack sealing and seal coating are recommended for both the parking lot and bituminous trail.
2. Pavement markings for the parking lot are recommended for designated parking places, including handicap parking.

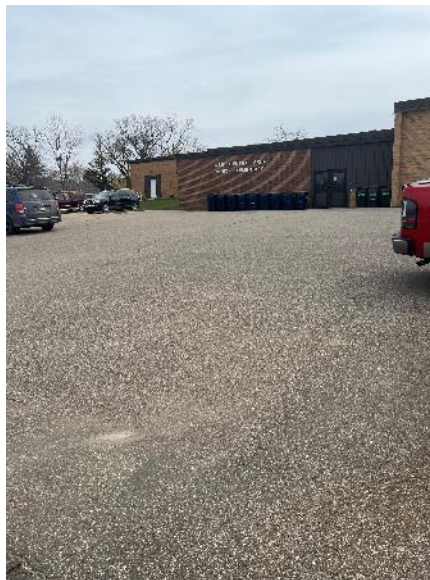
Parking lot on the west side of the facility.

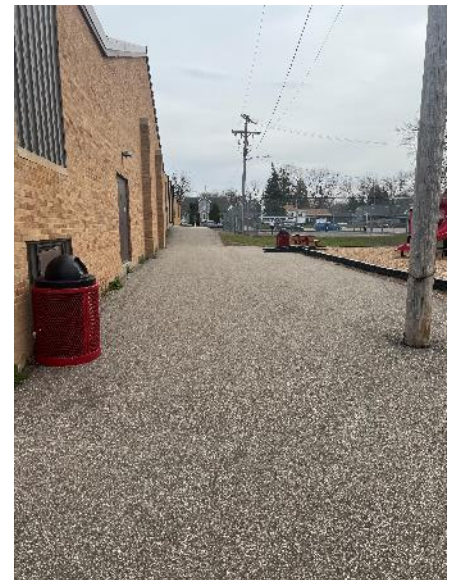
Bituminous trail along the south side of the facility.

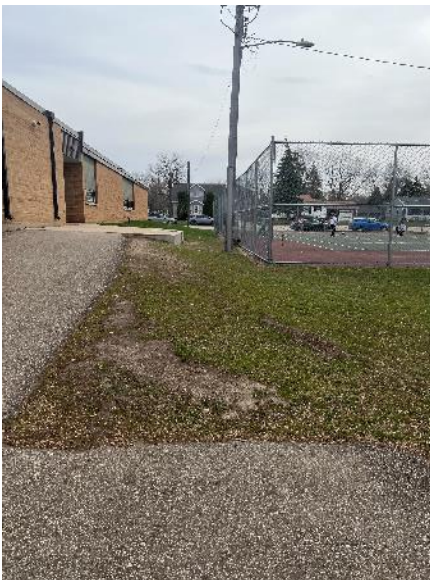
Green space by south facility entrance.

It is recommended to reseed and fertilize the green spaces on the south, west, and east (by the fuel tank as pictured below) sides of the facility to promote healthy turf growth.

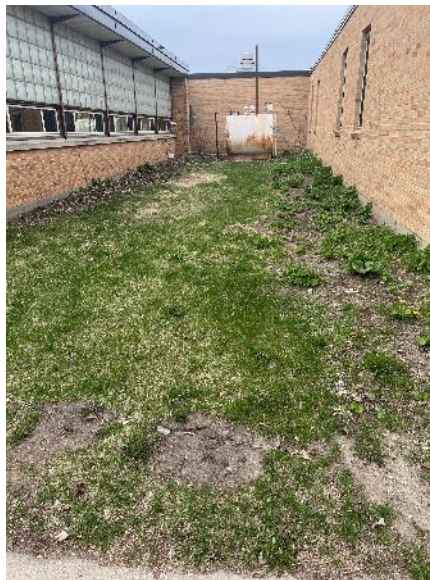
Green space by fuel tank.

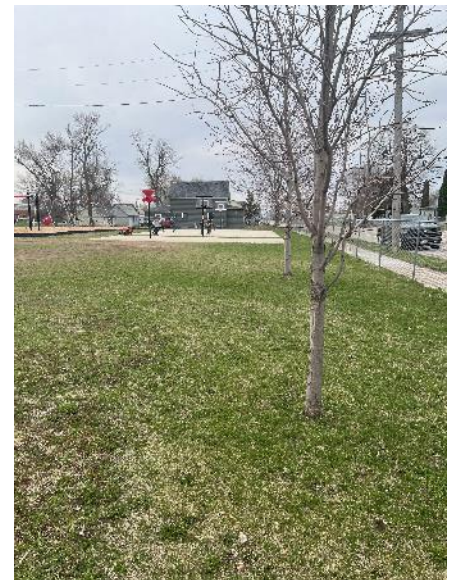
Green space on west side of facility.

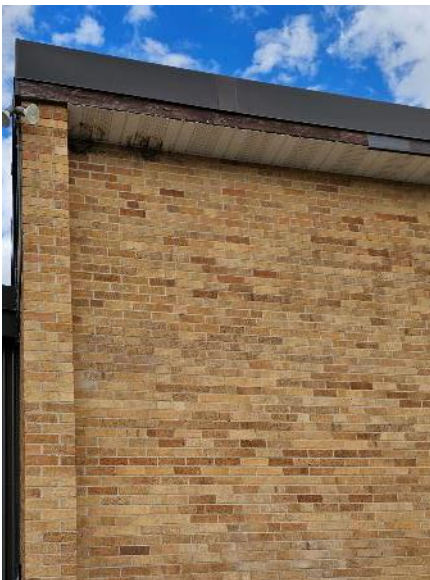
Portions of the perimeter fascia are damaged or missing, leaving the wooden sub-fascia exposed and creating a direct opening for unwanted water, air, and pest infiltration.

Missing section of metal fascia

At damaged and missing sections, inspect wooden sub-fascia for signs of decay. Replace sections of sub-fascia as required. Replace damaged sections of pre-finished metal fascia.

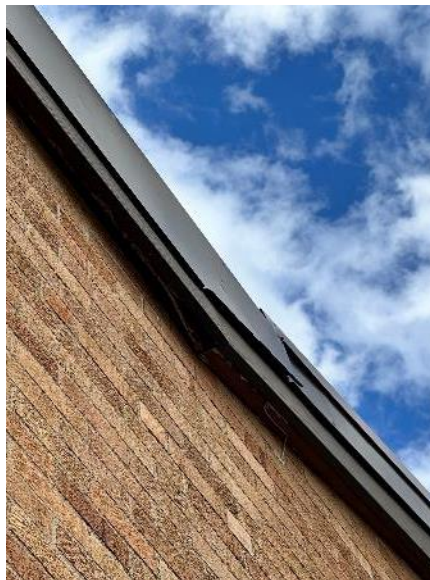
Wood rot at sub-fascia

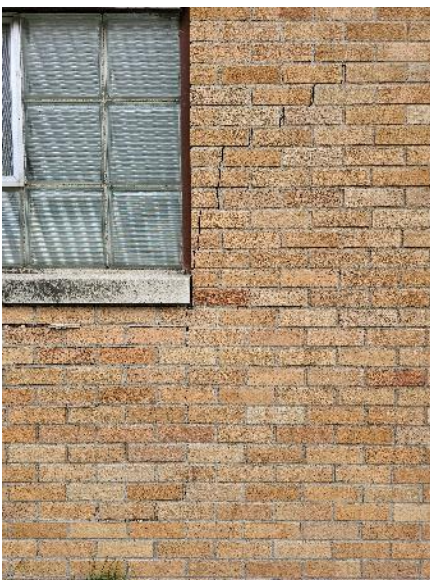
Various and numerous locations around the perimeter are showing signs of mortar & joint deterioration, especially near roof drains and downspouts.

**Exterior Envelope :** Across the facility, there are indications of settlement cracking and missing mortar that are both indicative of, and introduce, water and air infiltration issues for the building envelope. There are multiple instances where the exterior masonry and mortar are showing signs of significant deterioration due to the unintended presence of consistent moisture. Problems such as these as are the result of moisture movement and buildup. Each of these (and all similar) instances warrant further investigation to determine the sources of moisture intrusion prior to work.

Settlement cracking & joint deterioration

Prior to any mortar replacement work commencing, the building will need to be washed to remove the dirt and debris that has accumulated on the building over time. It is critical for the mortar to be in similar color, texture and compressive strength to match the existing mortar.

Broken blocks should be cut out and re-installed

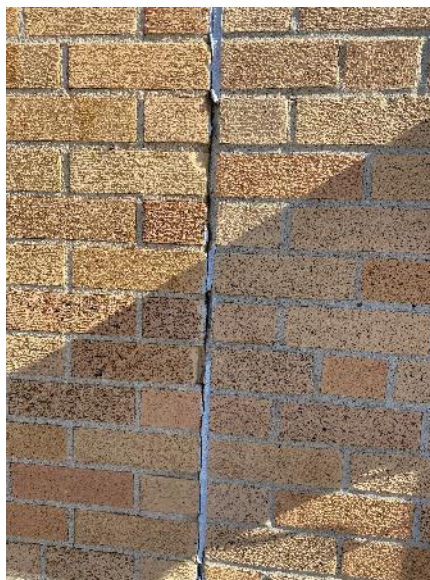
Deteriorated joints

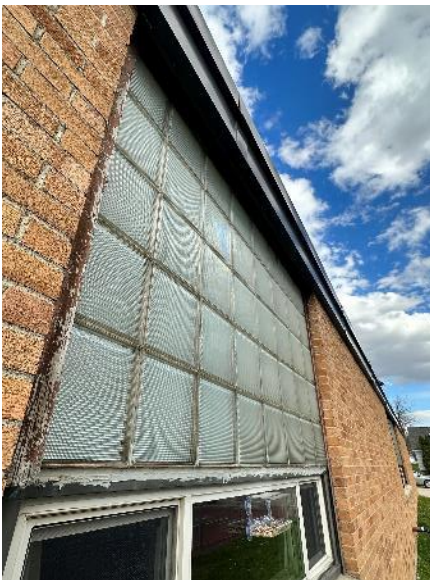
Beyond its useful life

Remove thermally inefficient existing windows and install new, thermally broken aluminum storefront windows and associated sealant, flashing and caulking. The new aluminum storefront windows will be energy efficient, prevent water and air infiltration into the building.

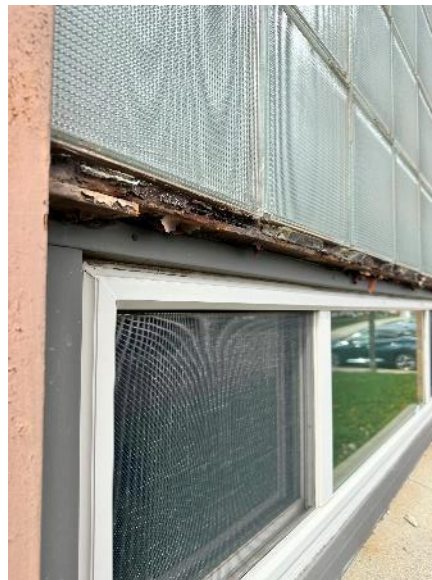
Beyond its useful life

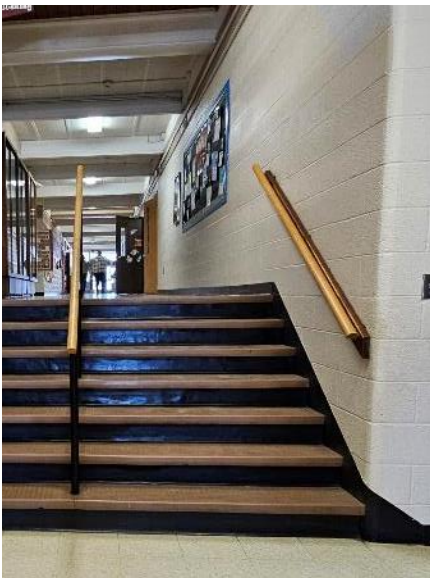
Non-compliant handrail extension

Update facility to meet all current Minnesota accessibility guidelines and building codes.

Minnesota Building Code requires a remodeling project expenditure of 20% of the construction budget for accessibility upgrades. For this reason, upgrades such as these should be looked at as part of any future addition/remodel project.

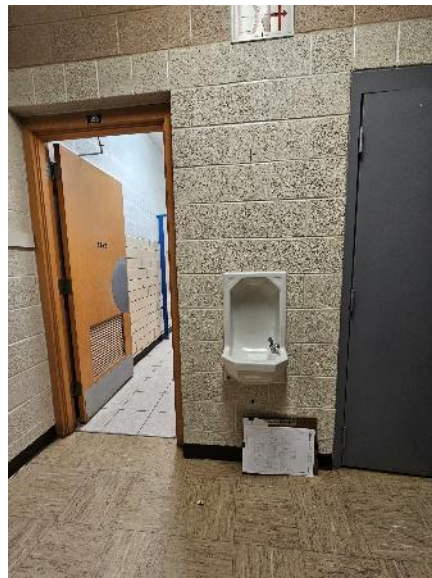
Non-accessible signage.

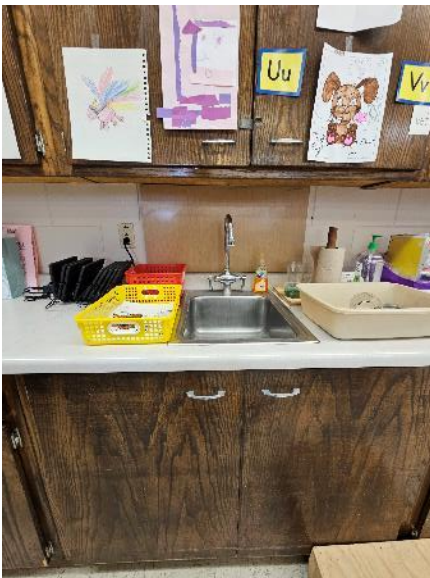
Non-accessible sinks & surface heights

Update facility to meet all current Minnesota accessibility guidelines and building codes.

Minnesota Building Code requires a remodeling project expenditure of 20% of the construction budget for accessibility upgrades. For this reason, upgrades such as these should be looked at as part of any future addition/remodel project.

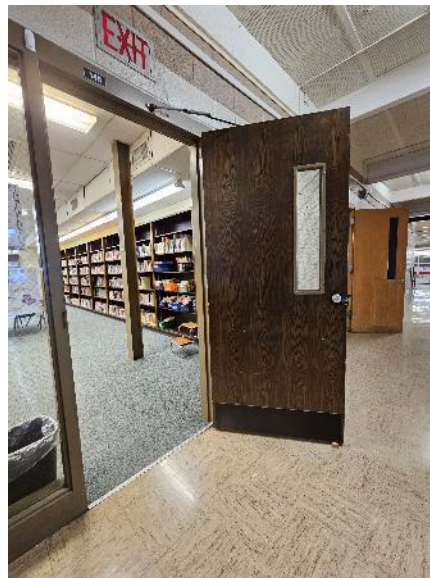
Non-accessible door hardware.

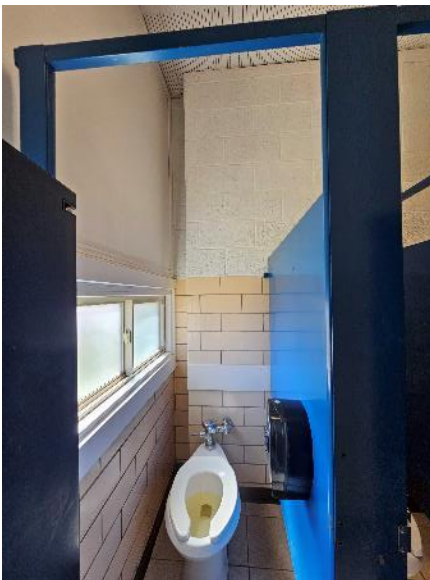
Restrooms throughout the building will need to be reconfigured to provide the adequate clearance at entry doors, around plumbing fixtures and within toilet stalls, as defined by the current Minnesota Accessibility Code. This reconfiguration would require a remodel and would impact the overall layout of the interior space of the building, including the relocation of the plumbing fixtures. In addition, the current Minnesota State Building Code requires impervious flooring materials and wall base, as well as cleanable wall finishes and ceiling materials. These items would be taken into consideration in a full restroom remodel.

Stalls lack compliant floor space & grab bars

Minnesota Building Code requires a remodeling project expenditure of 20% of the construction budget for accessibility upgrades. For this reason, upgrades such as these should be looked at as part of any future addition/remodel project.

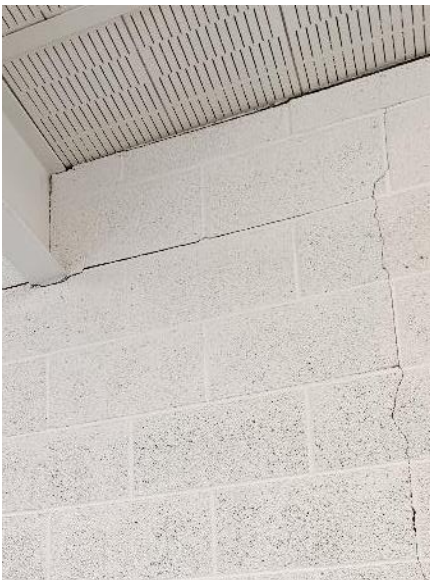
Wall cracks – likely due to settlement forces

Create a routine maintenance plan to perform annual inspections for the purpose of locating and identifying specific instances of cracking. Patch and repair as required.

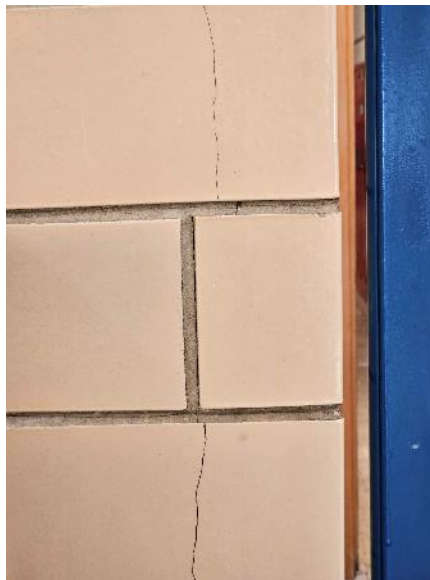
Cracking at wall tile

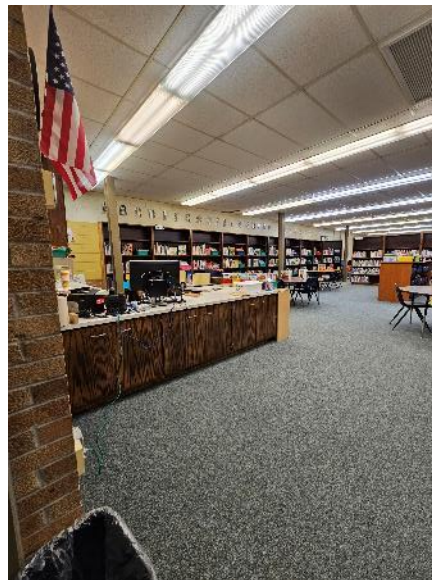
Typical library carpet

There is a mix of newer carpet tile selections and older roll-type carpet selections. Preparations should be made for planned upgrades to the older selections.

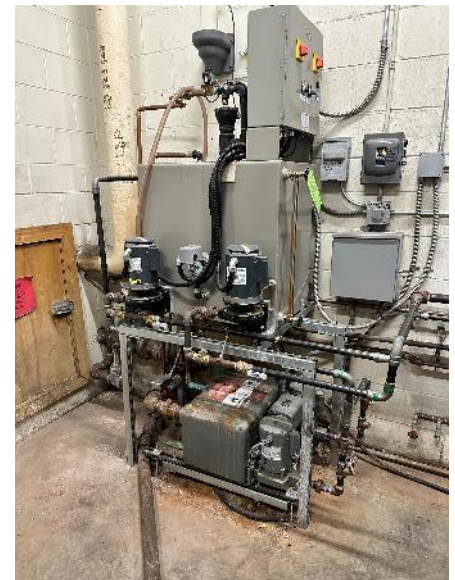
Electric Boiler

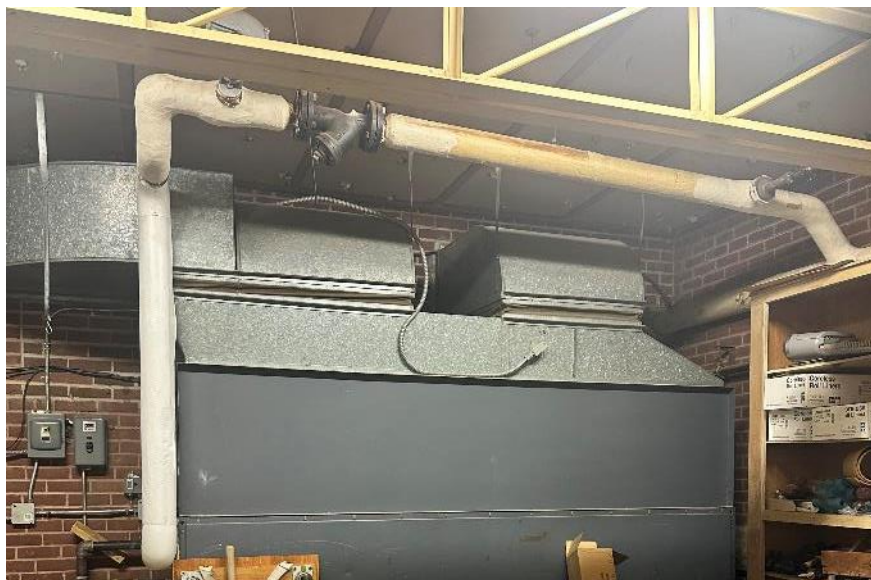
The building's steam distribution system is of the age where it has or will start to fail. A leaking steam pipe to one of the wings could result in inability to heat, school shutdowns, and possible damage to water lines if not addressed right away (like over a weekend). Fixes for the leaks might last but a different point may fail right after.

Steam distribution piping to AHU

Remove steam and condensate piping and replace with hot water hydronic piping, digital control valves, digital controls, and water treatment.

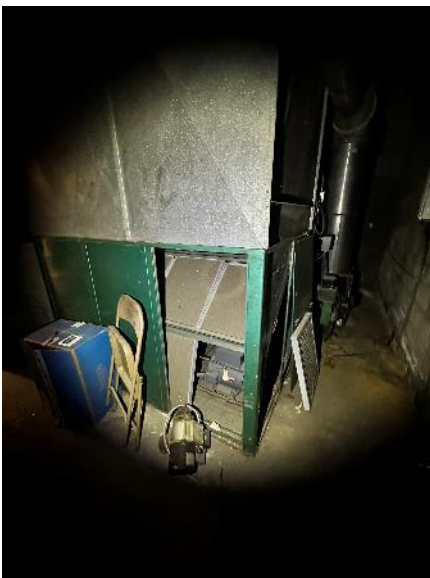
The AHUs, controls, and ductwork are beyond life and require significant effort to keep up with maintenance and repairs. These units have steam coils, constant speed fans, and pneumatic controls. They don't not have cooling coils or have the ability to add cooling. One AHU had its HTG coil replaced in 2023.

Inoperable Gym AHU

The Gymnasium unit should be replaced right away and sized to handle heating, cooling, and code required ventilation air.

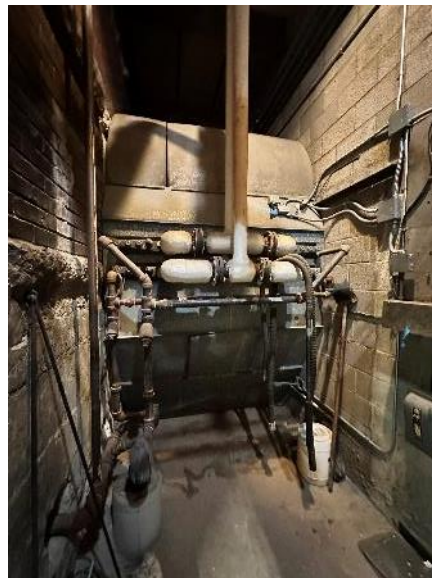
Southeast AHU

The classroom AHUs are operational for now but should be replaced with upgraded systems which employ more efficient technologies such as variable speed fans, digital controls, and more accurate outdoor air measures. The replacement units can be mounted in place or on the roof to gain more storage if needed. The new units shall be sized with cooling / dehumidification.

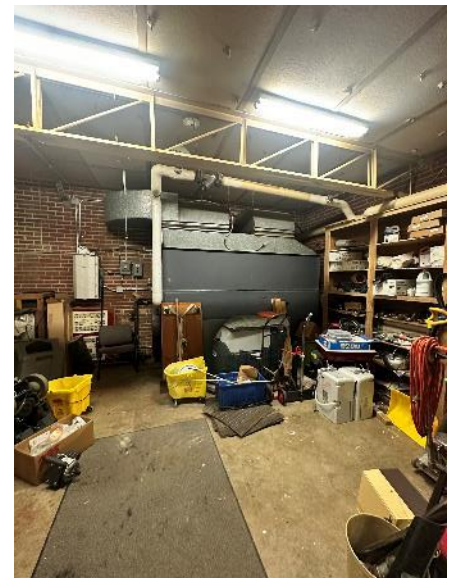
North AHU – New HTG coil in 2023

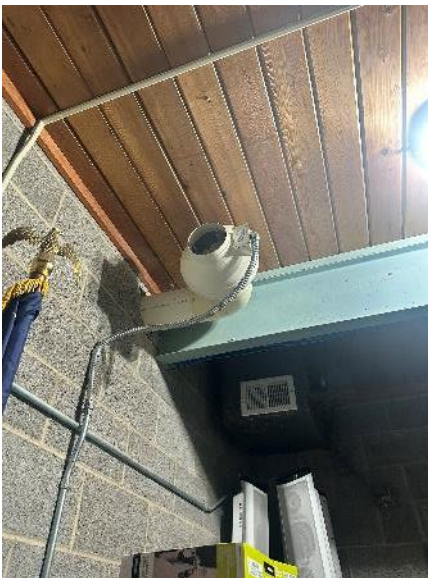
Through-Wall Air Conditioning Units used for the office is outdated and not operational. There is a PVC duct and inline fan which steals colder air from the office and supplies the IT room to provide some cooling. The Window AC unit is past it's useful life and does not meet MN energy Code for efficiency. The Fan is operational, but PVC is not allowed to be used as ductwork per the MN Mech Code. An IT room shall have independent cooling for proper operation and longer life of servers.

Inline fan to IT room

Remove through-wall air conditioners and patch walls to match existing. New HVAC system or Mini Split shall provide cooling for office and IT room.

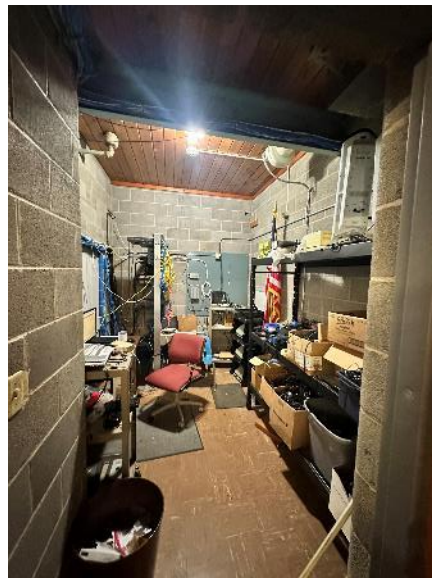
IT room with inline fan in upper right

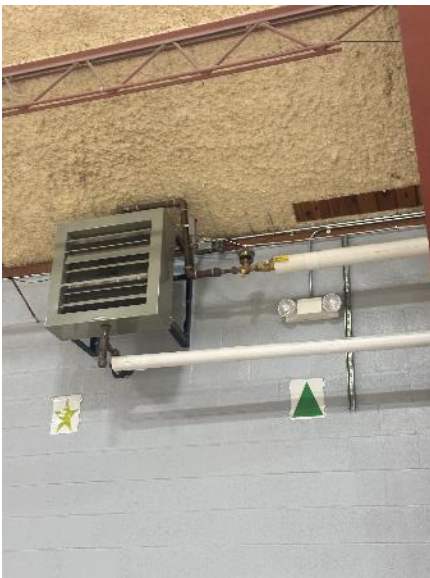
The school has four hanging unit heaters with only one being operational. During the walkthrough, we were told there are leaks in the three inoperable heat exchangers and they are disconnected.

Operational Unit heater serving Gym

Remove steam unit heaters, piping, controls and mounting hardware. New AHU or RTU will replace the heating, cooling, and ventilation capacities needed.

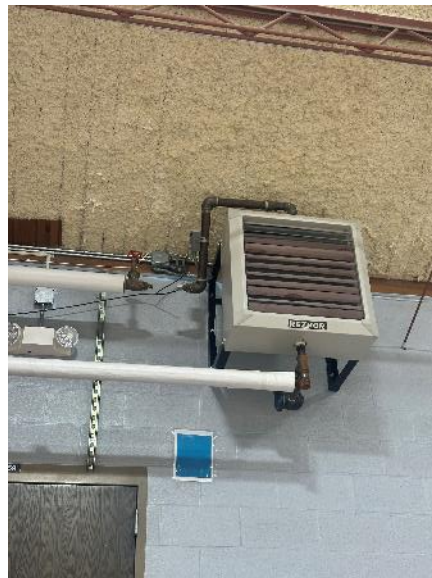
Disconnected Unit Heater

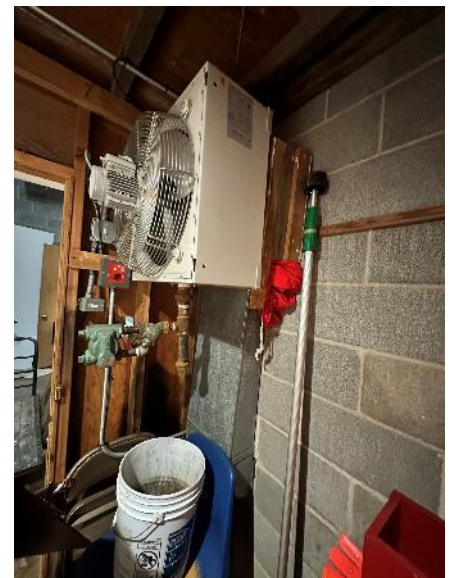
Disconnected Unit Heater

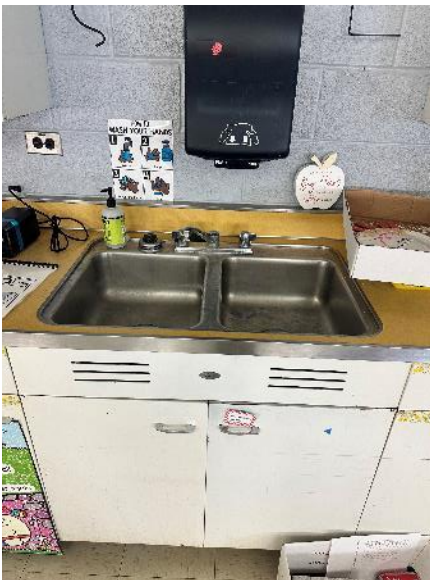
The plumbing fixtures, faucets, and flush valves have reached beyond their expected life. With a few exceptions, they are operational now and can be repaired or replaced as they fail.

Plumbing fixtures

Replace faucets on lavatories and sinks. Replace flush valves and water closets and urinals. Replace necessary fixtures with matching equipment. Budget for replacement of all fixtures within the next 10 years.

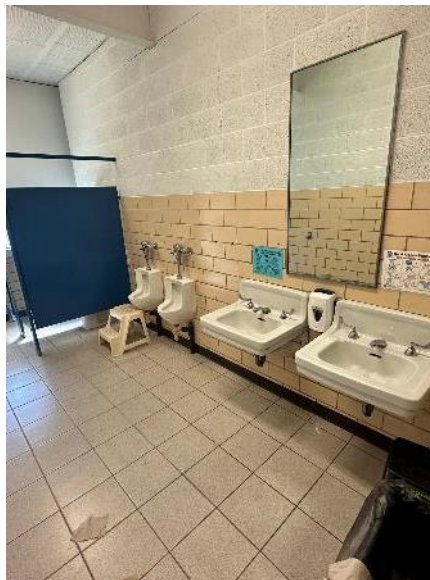
Faucets and flush valves show their age as well but are easier to replace. Some restrooms have flush valve water closets, and some have tank-type. The classroom sink with bubblers do not meet current code for separation distance.

Restroom fixtures

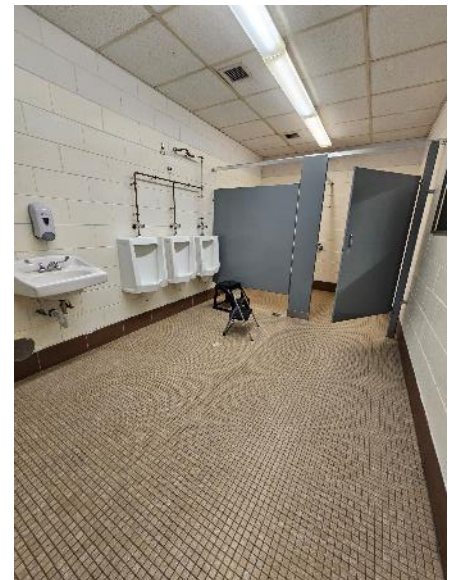
Fixtures with exposed/uninsulated piping

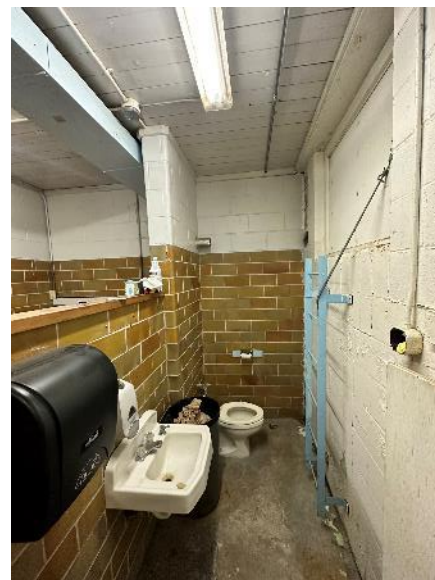
Unused restroom

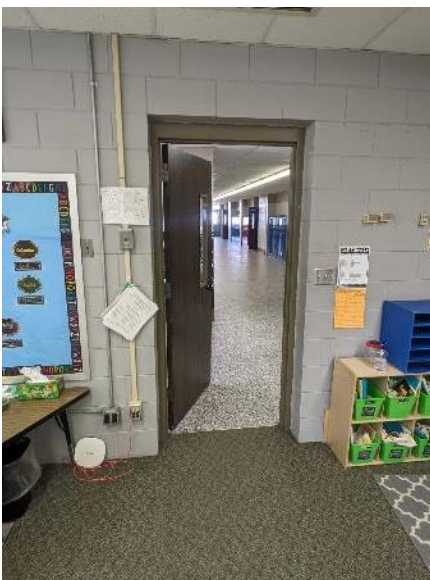
Examples of standard on/off switching in most locations.

- It is recommended to:
  1. Provide occupancy sensors throughout the building (Hallways, Bathrooms, Meeting Rooms, etc.), except for areas where automatic controls may present a safety concern (Mechanical, Electrical and Server Rooms, etc.)
  2. Provide dimming controls in offices and classrooms and other similar spaces.
  3. Provide daylighting sensors in spaces with lots of incoming natural light, such as offices and classrooms with exterior windows, etc.

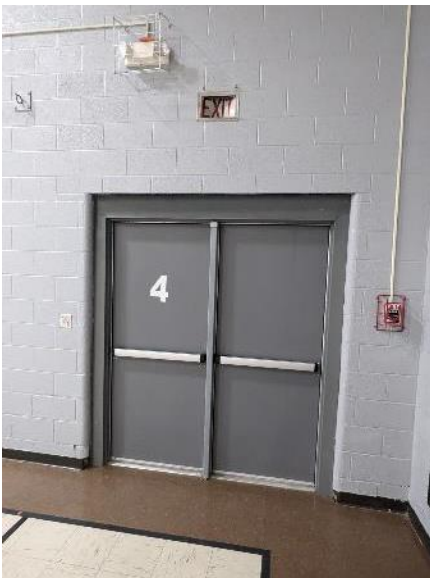
Damaged Exit Sign in Gymnasium 162

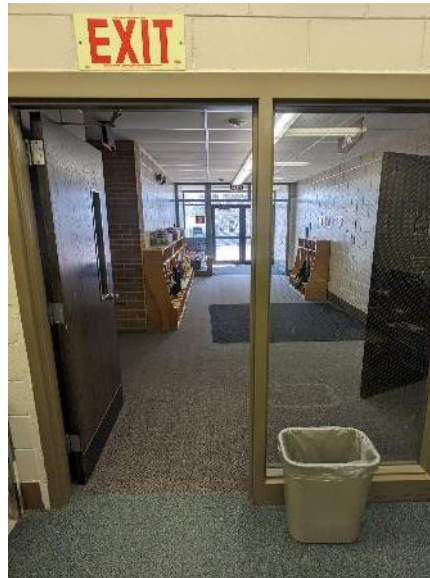
- Custodial Office/Storage 117 (total of 1)
- Home Economics Classroom 139 (total of 2)
- Corridor 136 adjacent Kindergarten 119, and Corridor 142 (total of 2)
- Exit signs in Library 145 (total of 2)
- Exit signs in Music Rm 159 (total of 2)

Non-illuminated Sign in Library 145.

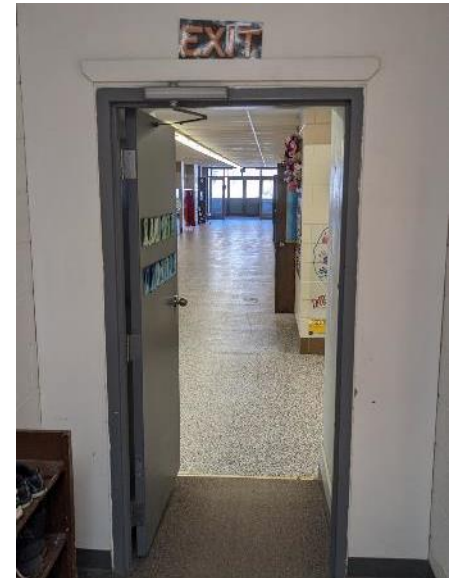
Non-illuminated Sign in Corridor 142.

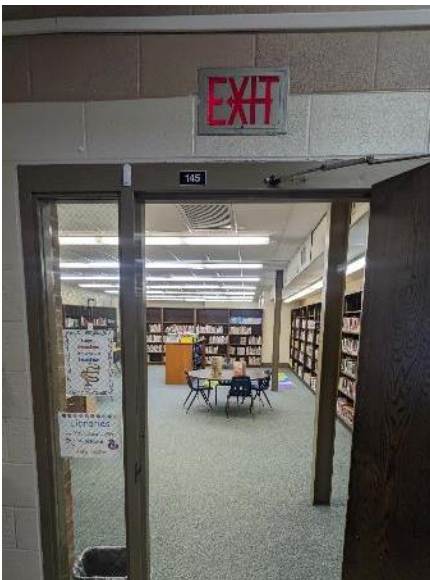
Examples of exit signs and emergency lights that require annual testing.

It is recommended to conduct annual testing of all powered exit sign and emergency lights, and repair and/or replacement of exit signs and emergency lights as needed.

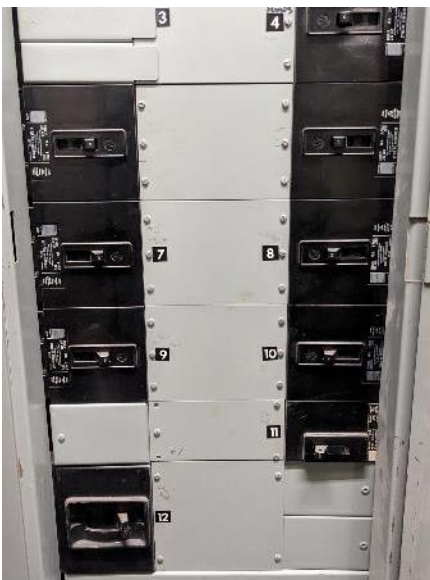
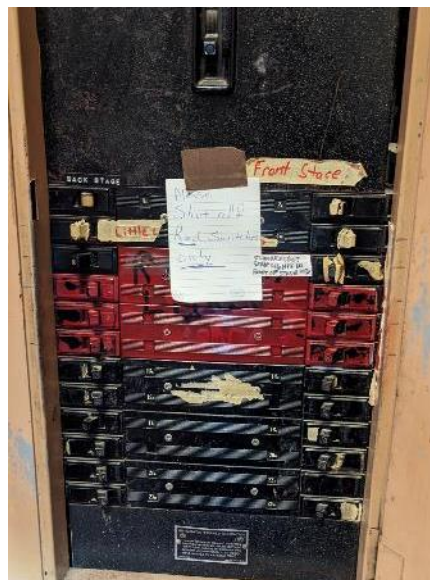
Examples of panels needing updated labels and circuit directories

It is recommended to hire an electrician to verify all the electrical loads in the building and provide up-to-date labeling and circuit directories for all the electrical distribution equipment.

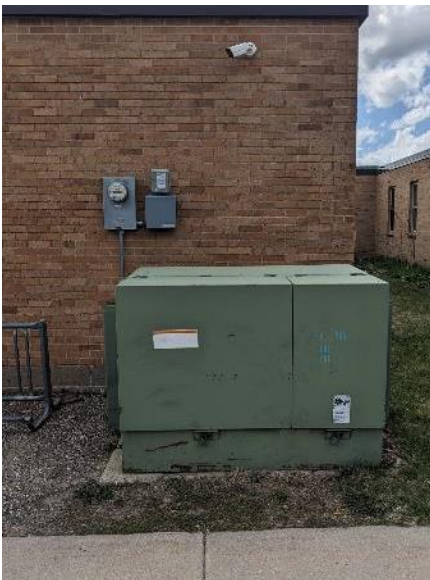
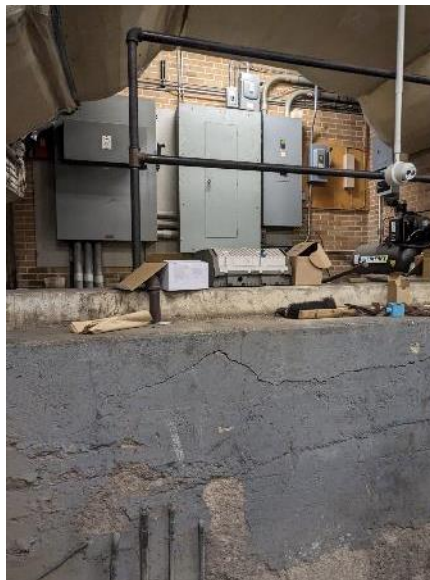
Examples of electrical equipment needing annual preventative maintenance

**ELO 5a** - Have thermal testing conducted on all electrical distribution equipment (ie: transformers, metering cabinets, panels, disconnects, VFD's, etc.). This can help find loose connections, detect overloaded circuits or potential failure points that could lead to costly equipment damage and/or injuries to personnel.

**ELO 5b** - Have electrical panels and distribution equipment cleaned. Dust build-up in panels can lead to nuisance tripping of circuit breakers, or even arcing and catastrophic failure in extreme cases.
